[Docket No. FAA-2016-4228; Directorate Identifier 2015-NM-107-AD]

#### Airworthiness Directives; Airbus Airplanes

**SUMMARY:** We propose to supersede Airworthiness Directive (AD) 2014-13-12, for all Airbus Model A318, A319, A320, and A321 series airplanes. AD 2014-13-12 currently requires identifying the part number and serial number of each passenger oxygen container, replacing the oxygen generator manifold of any affected oxygen container with a serviceable manifold, and performing an operational check of the manual mask release, and doing corrective actions if necessary. Since we issued AD 2014-13-12, we have determined that affected containers have not only been marked with company name B/E Aerospace, as was specified, but also, for a brief period, with the former company name DAe Systems. This proposed AD would retain the requirements of AD 2014-13-12, and require replacing the oxygen generator manifold of any affected DAe oxygen container with a serviceable manifold. We are proposing this AD to detect and correct non-serviceable oxygen generator manifolds, which could reduce or block the oxygen supply and result in injury to passengers when oxygen supply is needed.

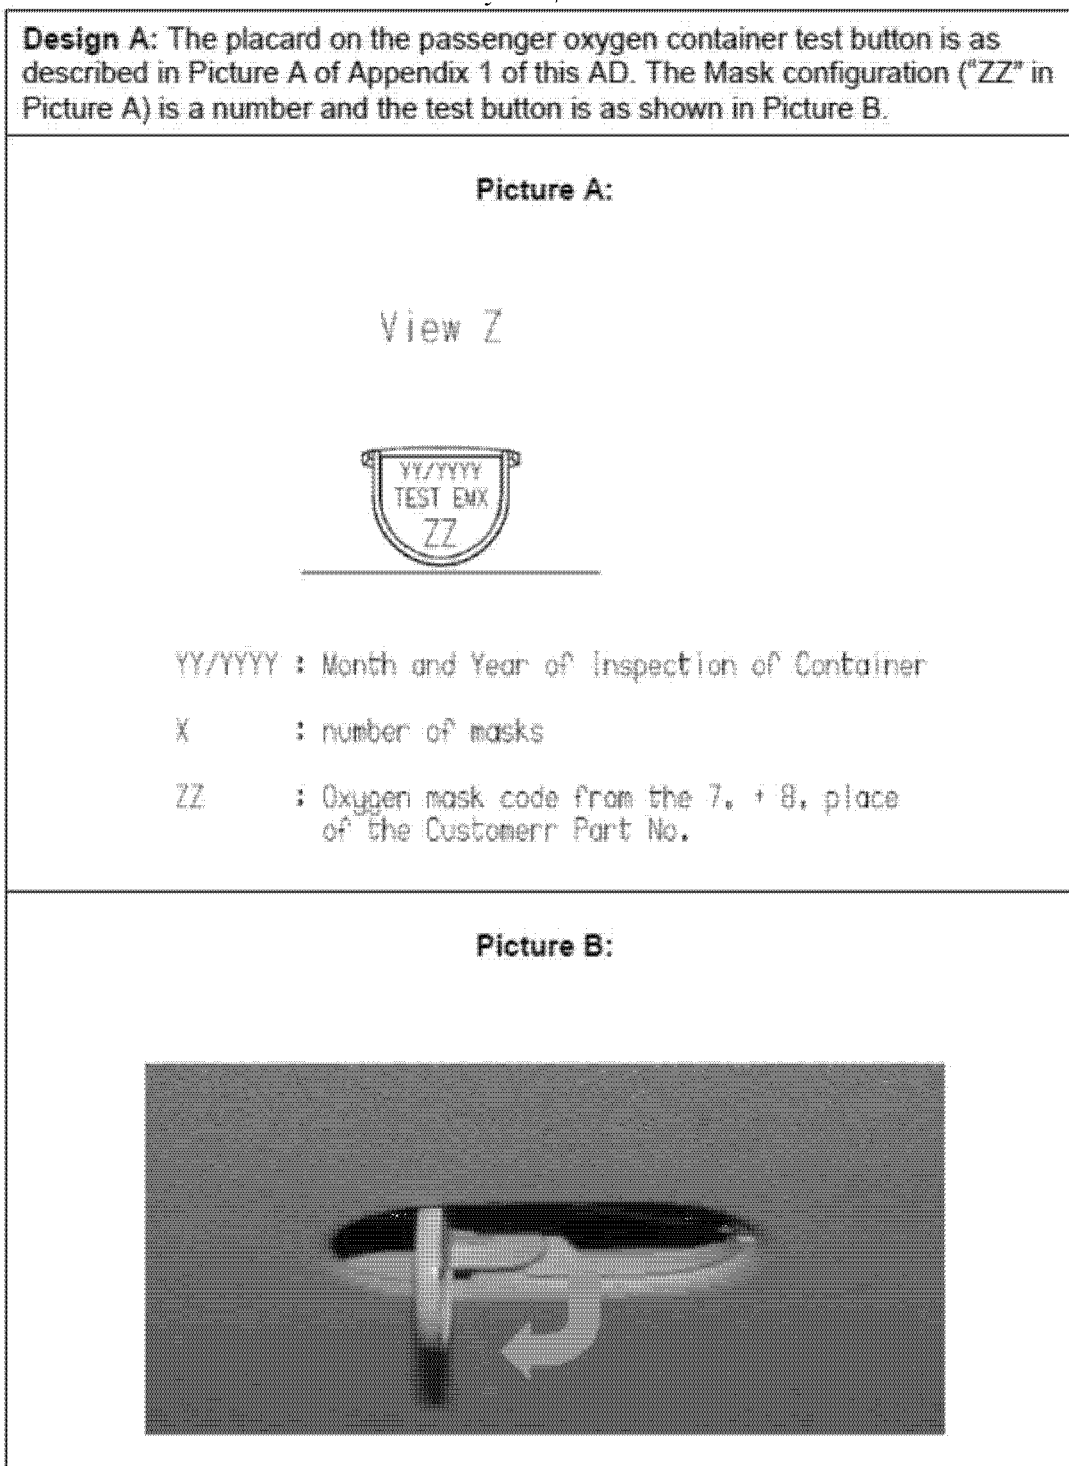
Figure 1 to paragraph (i)(7) of this AD – Design A of the Passenger Oxygen Containers Affected by this AD

(7) The requirements of paragraphs (g) and (h) of this AD apply only to passenger oxygen containers that are Design A, as defined in figure 1 to paragraph (i)(7) of this AD.

**Note 1 to figure 1 to paragraph (i)(7) of this AD:** Figure 1 is a reproduction of material from EASA AD 2012–0083, dated May 16, 2012. The words "Appendix 1 of this AD" in this figure refer to Appendix 1 of EASA AD 2012–0083, dated May 16, 2012.

**Note 2 to figure 1 to paragraph (i)(7) of this AD:** For "Design A," the placard on the passenger oxygen container test button is as

described in "Picture A" in figure 1 to paragraph (i)(7) of this AD. The mask configuration ("ZZ" in "Picture A") is a number, and the test button is as shown in "Picture B."
