[Docket No. FAA-2015-3989; Directorate Identifier 2014-NM-250-AD; Amendment 39-18600; AD 2016-16-02]

Airworthiness Directives; Airbus Airplanes

SUMMARY: We are adopting a new airworthiness directive (AD) for all Airbus Model A318, A319, A320, and A321 series airplanes. This AD was prompted by reports of premature aging of certain passenger chemical oxygen generators that resulted in the generators failing to activate. This AD requires an inspection to determine if certain passenger chemical oxygen generators are installed and replacement of affected passenger chemical oxygen generators. We are issuing this AD to prevent failure of the passenger chemical oxygen generator to activate and consequently not deliver oxygen during an emergency, possibly resulting in injury to the airplane occupants.

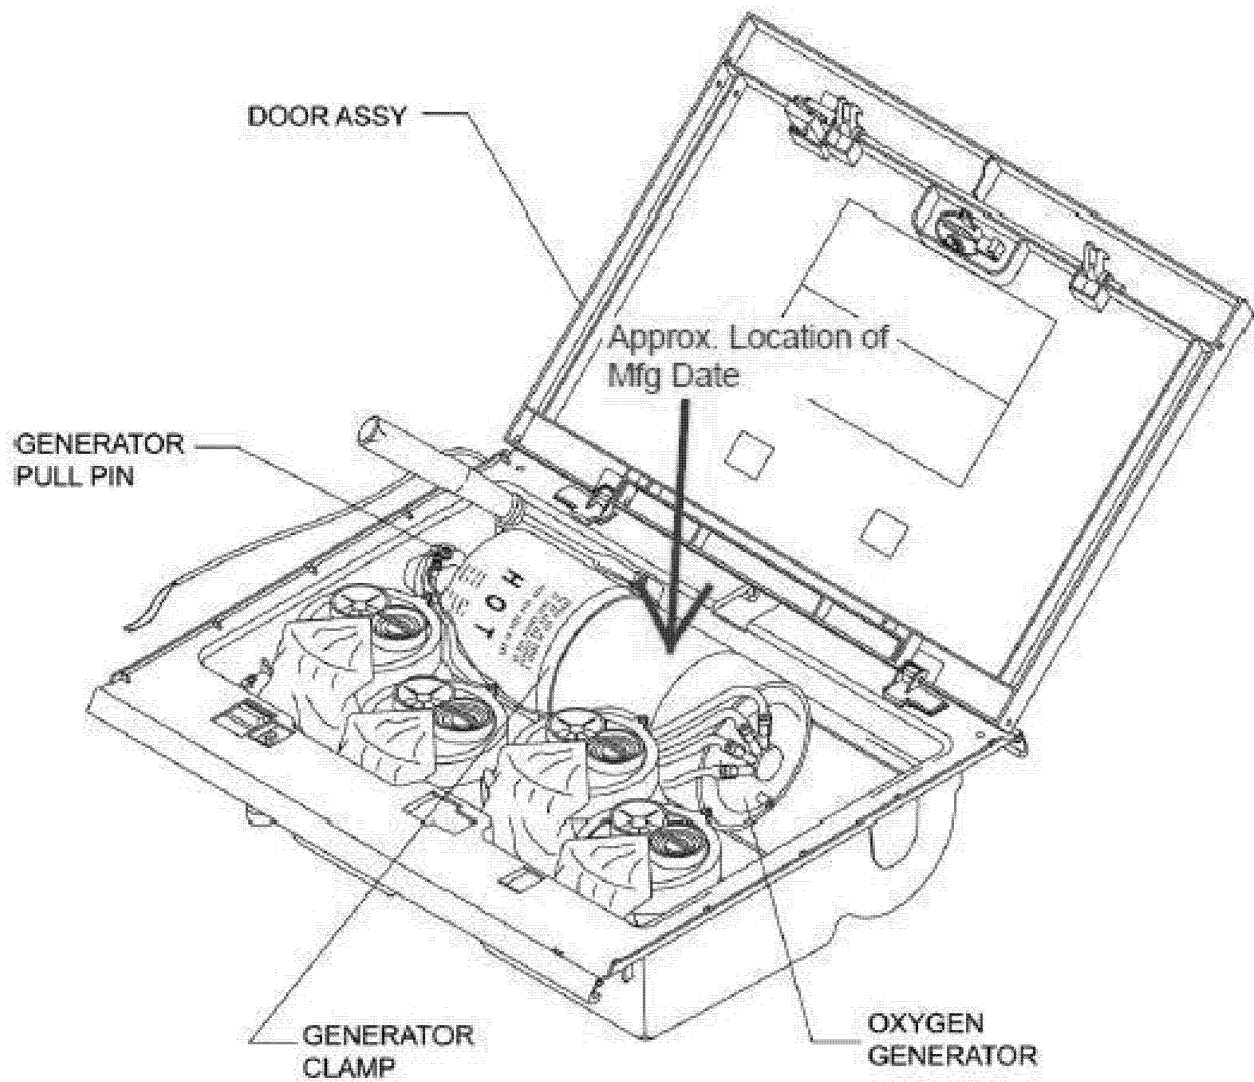
Figure 1 to Paragraph (g) of this AD - Location of Date (MM-YY)

Within 30 days after the effective date of this AD: Do a one-time inspection of passenger chemical oxygen generators, part numbers (P/N) 117042–02 (15 minutes (min)—2 masks), 117042–03 (15 min—3 masks), 117042–04 (15 min—4 masks), 117042–22 (22 min—2 masks), 117042–23 (22 min—3 masks), and 117042–24 (22 min—4 masks) to determine the date of manufacture as specified in Airbus Alert Operators Transmission (AOT) A35N006–14, dated December 10, 2014, including Appendix 1. Refer to figures 1 and 2 to paragraph (g) of this AD for the location of the date. A review of airplane maintenance records is acceptable for the inspection required by this paragraph, provided the date of manufacture can be conclusively determined by that review.
