[Docket No. 96-CE-09-AD]

Airworthiness Directives; The New Piper Aircraft, Inc. PA24, PA28R, PA30, PA32R, PA34, and PA39 Series Airplanes

ACTION: Notice of proposed rulemaking (NPRM).

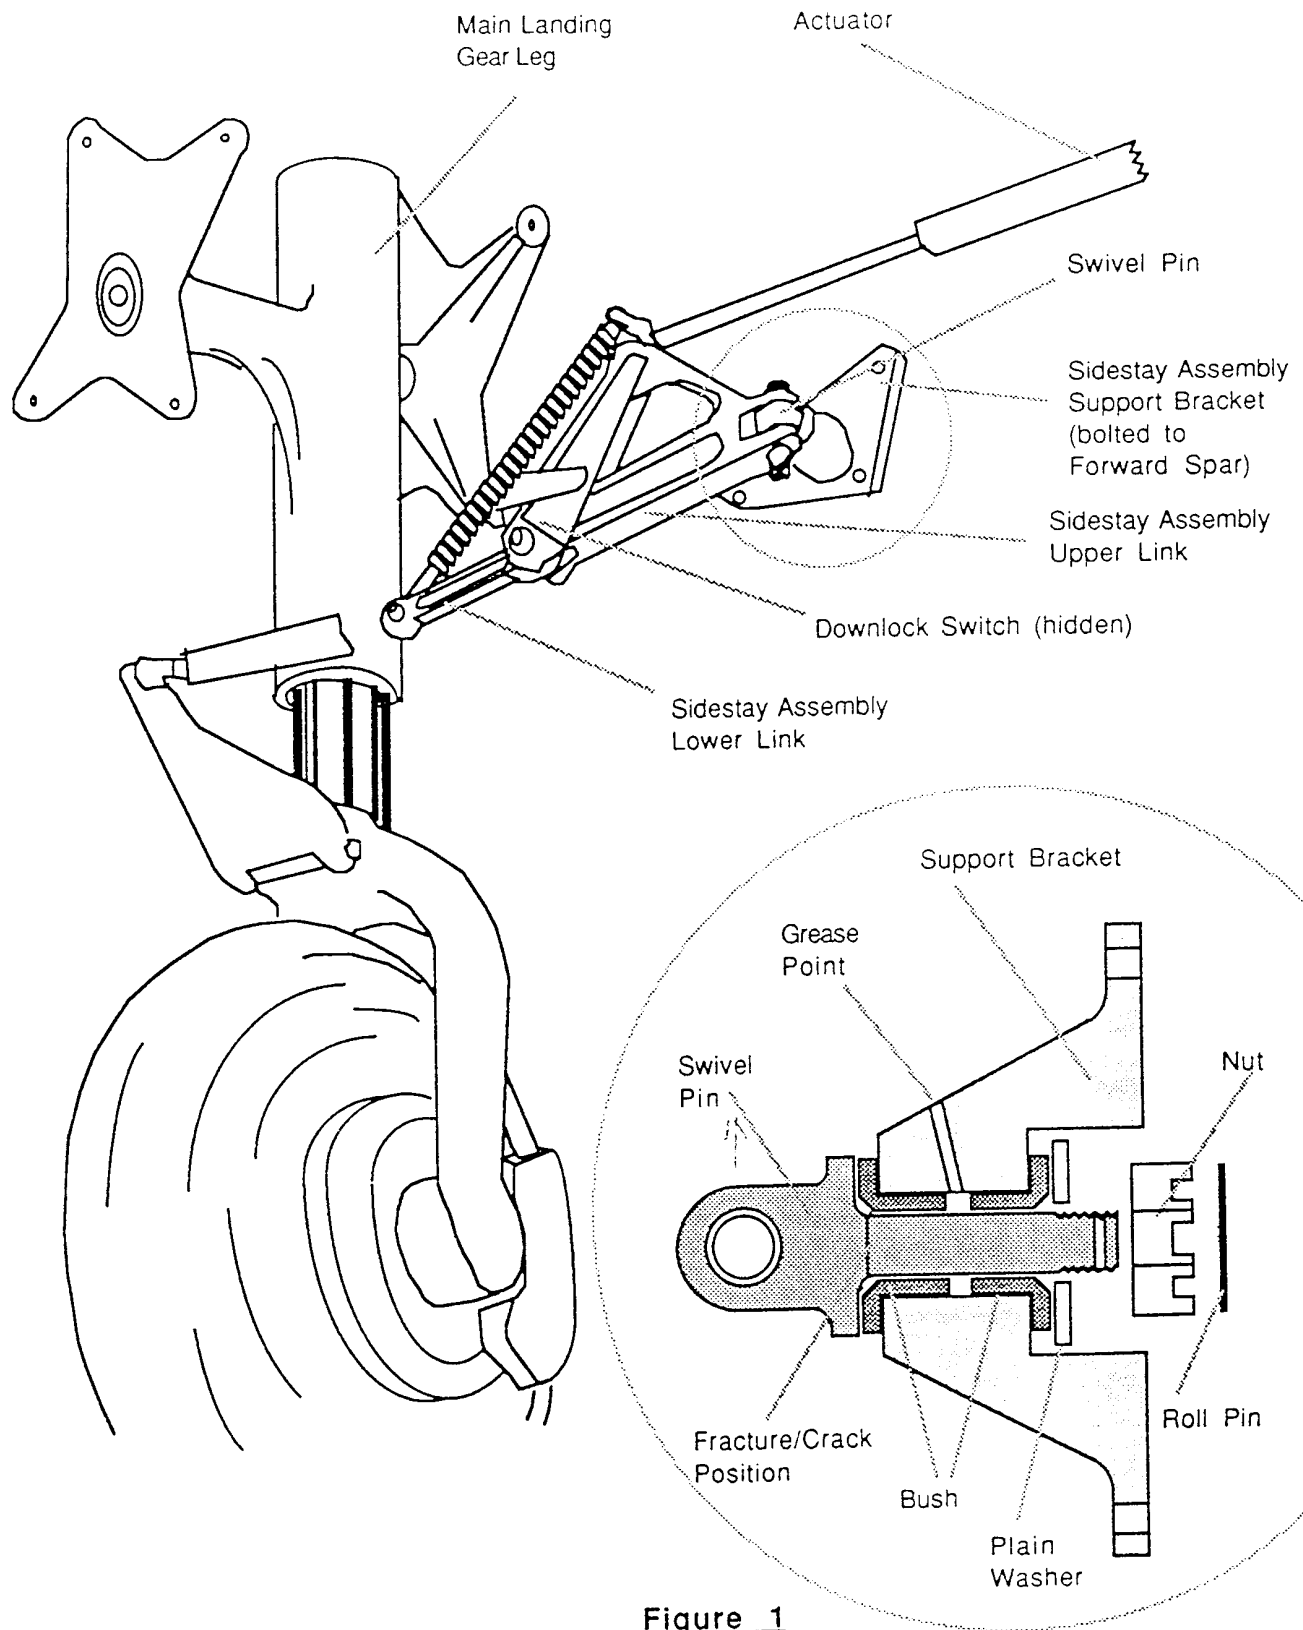
**Figure 1**

(a) Remove both the left and right main gear side brace studs from the airplane in accordance with the instructions contained in the Landing Gear section of the maintenance manual, and inspect each main gear side brace stud for cracks, using Type I (fluorescent) liquid penetrant or magnetic particle inspection methods. Figure 1 of this

AD depicts the area of the sidebrace stud shank where the sidebrace stud is to be inspected.

(1) For any main gear side brace stud found cracked, prior to further flight, replace the cracked stud with an FAA-approved serviceable part (part numbers referenced in the table in paragraph (b) of this AD or FAA-approved equivalent) in accordance with the instructions contained in the Landing Gear section of the applicable maintenance manual, and accomplish one of the following, as applicable:

(b) Reinspect both the left and right main gear side brace studs, using Type I (fluorescent) liquid penetrant or magnetic particle inspection methods. Replace any cracked stud or reinstall any uncracked stud as specified in paragraphs (a)(1) and (a)(2) of this AD, respectively:
