[Docket No. 95-NM-277-AD; Amendment 39-9537; AD 96-06-01]

**Airworthiness Directives; Boeing Model 757 Series Airplanes Equipped With Abex Spoiler Actuators**

96-06-01 Boeing: Amendment 39-9537. Docket 95-NM-277-AD.

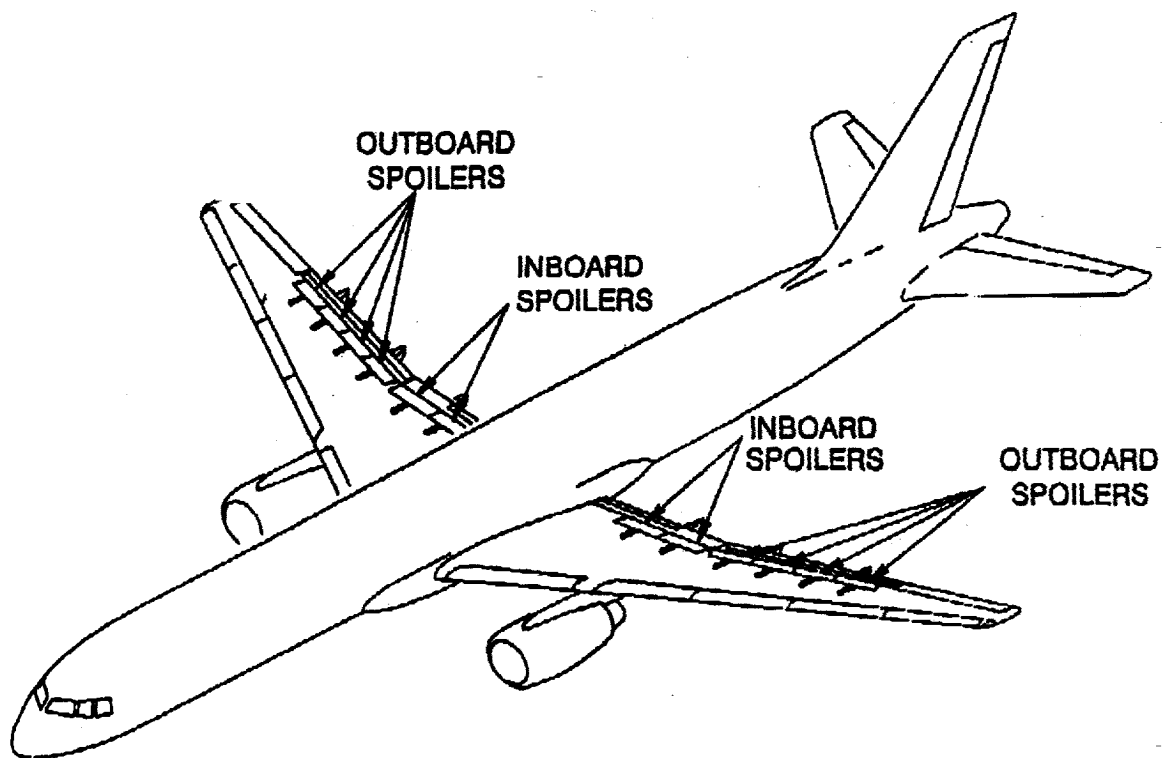
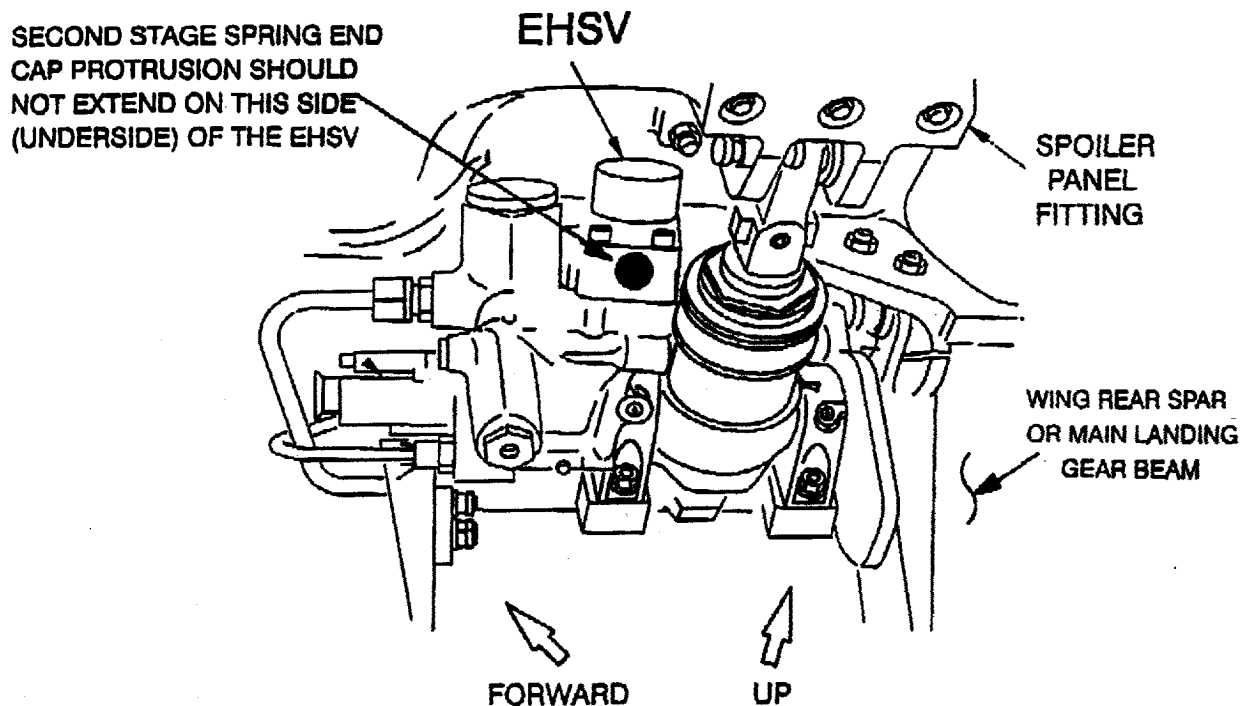
If the jet pipe in the first stage of the EHSV is plugged, or if the differential pressure between the extend and retract ports pressurized by the jet pipe is inadequate, an incorrectly installed bias spring on the second stage spool would cause the spoiler to be driven into the "deploy" position. Such inadvertent spoiler deployment would result in the airplane experiencing a rolling moment. If the airplane is already banked or is at a low altitude, or if the crew does not respond rapidly enough to control the uncommanded roll, a significant control upset of the airplane could result.

(1) While the airplane is on the ground, extend the flaps to 40 degrees, and visually inspect the spoiler actuator EHSV assembly to determine the location of the second stage bias spring end cap assembly.

Note 2: To be correctly positioned, the second stage bias spring cap assembly should be on the upper or forward side of the EHSV assembly. Appendix 1 of this AD provides a visual representation of the correct positioning of the EHSV assembly.

(2) If the second stage bias spring cap assembly is on the aft or lower side of the EHSV assembly, prior to further flight, replace the EHSV, having Abex part number 72196, with a serviceable unit in accordance with the airplane maintenance manual.
