[Docket No. 97-SW-15-AD; Amendment 39-10153; AD 97-20-16]

Airworthiness Directives; Eurocopter Deutschland GmbH (ECD) (Eurocopter) Model MBB-BK117 A-1, A-3, A-4, B-1, B-2, and C-1 Helicopters

97-20-16 Eurocopter Deutschland GmbH (ECD): Amendment 39-10153. Docket No. 97-SW-15-AD. Supersedes priority letter AD 97-09-16.

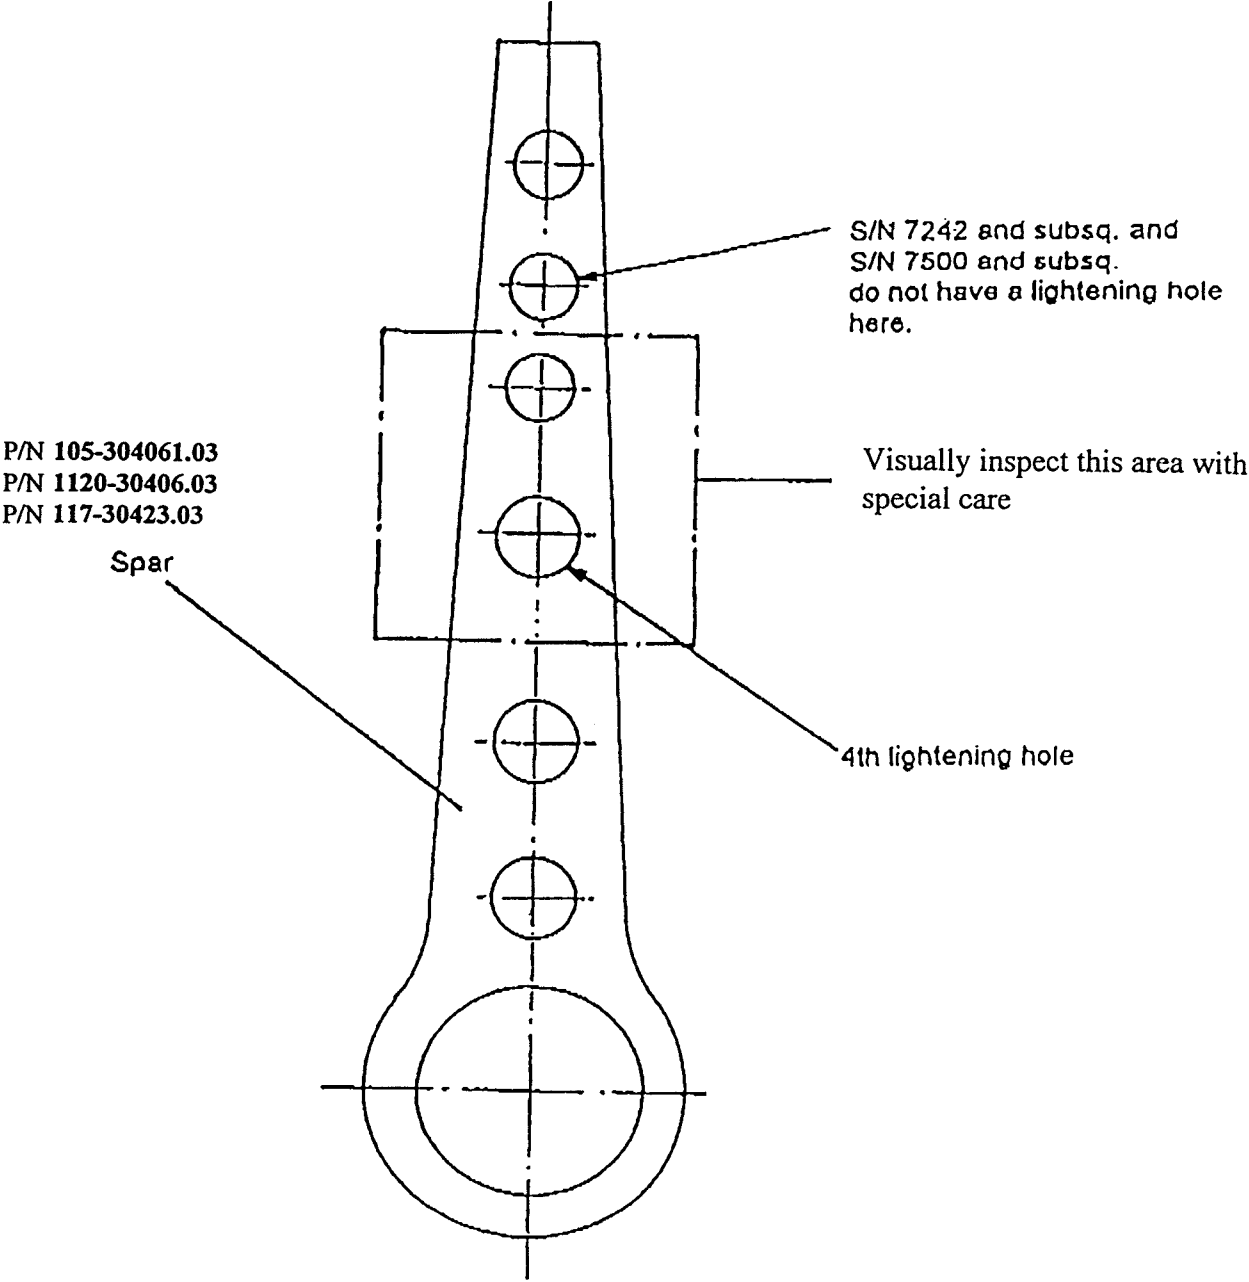
Figure 1

(1) Both surfaces of the vertical fin spar, part number (P/N) 105-304061.03, P/N 1120-30406.03, or P/N 117-30423-03, paying particular attention to the area extending from the top edge of the third lightening hole from the top of the vertical fin spar to halfway between the fourth and fifth lightening hole (see Figure 1).

(b) If a crack or loose rivet is found in the area described in paragraph (a) of this AD (see Figure 1), before further flight, repair in accordance with the Appendix, "Repair of BK117 Vertical Fin", to Eurocopter Alert Service Bulletin MBB-BK117 No. ASB-MBB-BK117-30-106, Revision 3, dated May 5, 1997. Thereafter, perform the inspection described in paragraph (a) of this AD at intervals not to exceed 300 hours TIS.

(e) Within 600 hours TIS after the effective date of this AD, accomplish the repair to the vertical fin in accordance with the Appendix, "Repair of BK117 Vertical Fin", to Eurocopter Alert Service Bulletin MBB-BK117 No. ASB-MBB-BK117-30-106, Revision 3, dated May 5, 1997. Thereafter, perform the visual inspection required by paragraph (a) of this AD at intervals not to exceed 300 hours TIS.
