[Docket No. 98-CE-01-AD]

Airworthiness Directives; Maule Aerospace Technology Corp. M-4, M-5, M-6, M-7, MX-7, and MXT-7 Series Airplanes and Models MT-7-235 and M-8-235 Airplanes

ACTION: Notice of proposed rulemaking (NPRM).

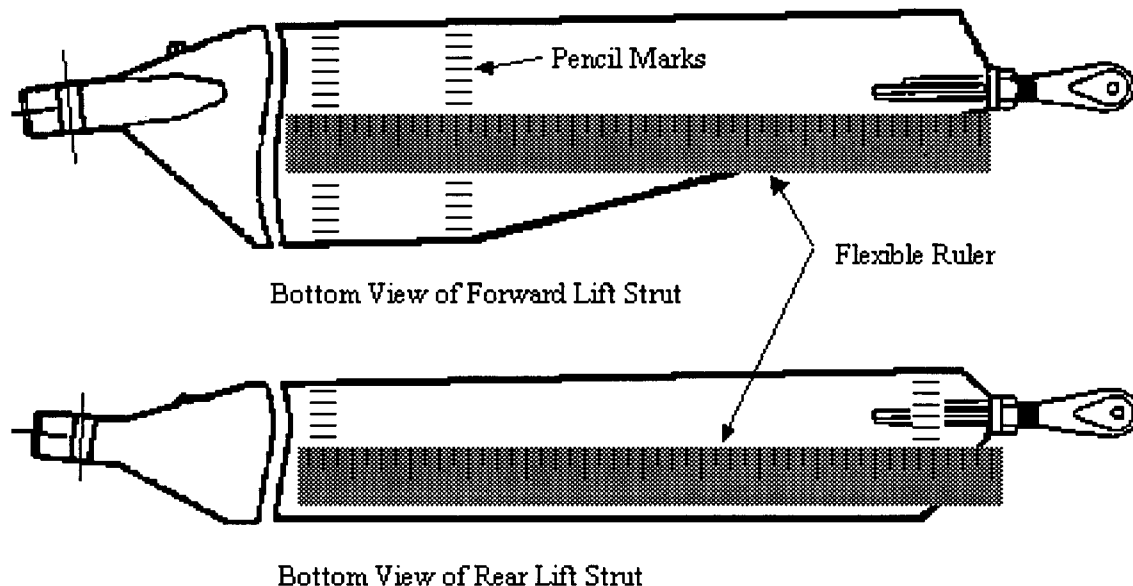
Figure 1

2. Using a flexible ruler, draw a 1/4-inch grid on the surface of the first 11 inches from the lower end of the strut as shown in Piper Service Bulletin No. 528D or 910A, as applicable. This can be done using a soft (#2) pencil and should be done on both faces of the strut. As an alternative to drawing a complete grid, make two rows of marks spaced every 1/4 inch across the width of the strut. One row of marks should be about 11 inches from the lower end of the strut, and the second row should be several inches away where the strut starts to narrow. Lay the flexible ruler between respective tick marks of the two rows and use tape or a rubber band to keep the ruler in place. See Figure 1.

8. A measurement of 0.024 inch or less shall require replacement of the strut prior to further flight.
