[Docket No. 99-SW-02-AD]

Airworthiness Directives; Bell Helicopter Textron-manufactured Model HH-1K, TH-1F, TH-1L, UH-1A, UH-1B, UH-1E, UH-1F, UH-1H, UH-1L, and UH-1P Helicopters; and Southwest Florida Aviation SW204, SW204HP, SW205, and SW205A-1 Helicopters

ACTION: Notice of proposed rulemaking (NPRM).

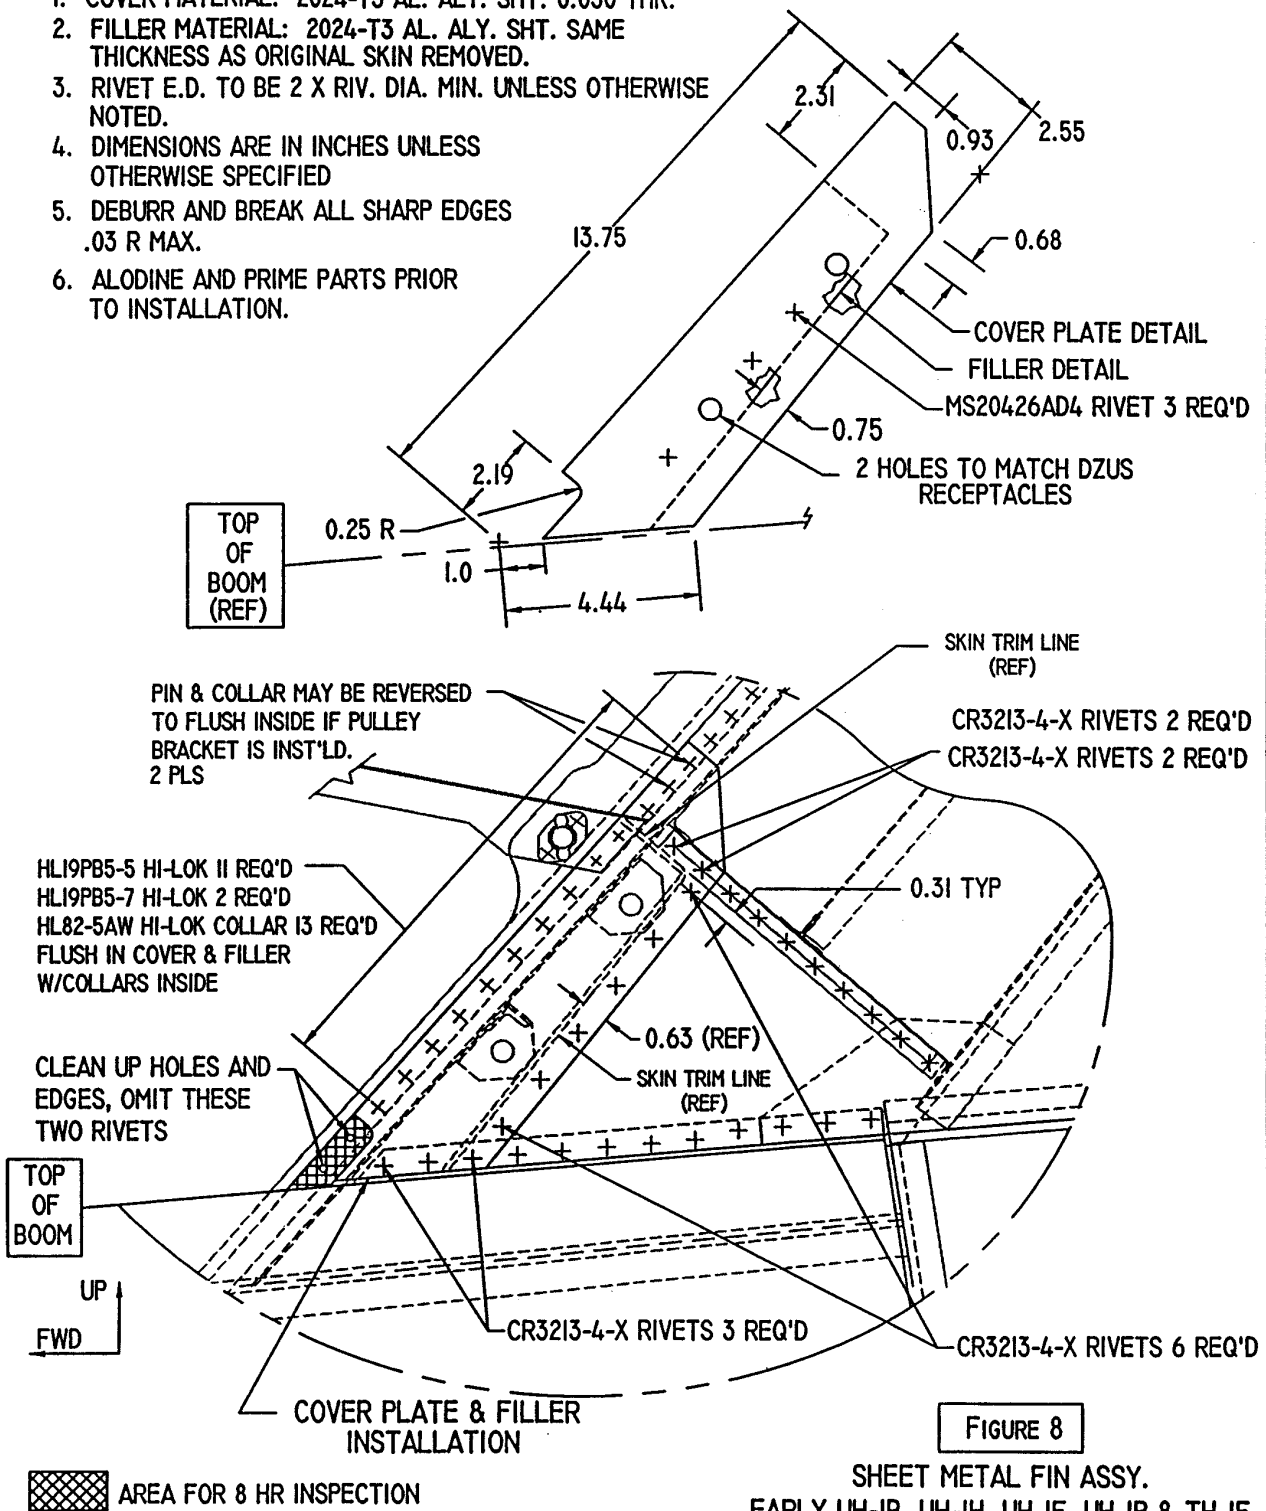
**FIGURE 8**

SHEET METAL FIN ASSY.
EARLY UH-1B, UH-1H, UH-1F, UH-1P & TH-1F
(REF)

(5) Fabricate cover plates in accordance with the notes and drawings of Figure 8 or 9, whichever is applicable. Ream prepare the holes in the fin spar and parts and install HI-LOK fasteners.

(5) After inspection, apply zinc chromate primer to the bare surfaces. When dry, re-install the cover plate and the filler using fasteners specified in Figure 8 or 9, whichever is applicable.
