## DEPARTMENT OF TRANSPORTATION

[Docket No. 98-SW-40-AD; Amendment 39-11039; AD 98-19-04]

#### **Airworthiness Directives; Agusta S.p.A. Model A109C, A109E, and A109K2 Helicopters**

**AD 98-19-04 Agusta S.p.A.:** Amendment 39-11039. Docket No. 98-SW-40-AD.

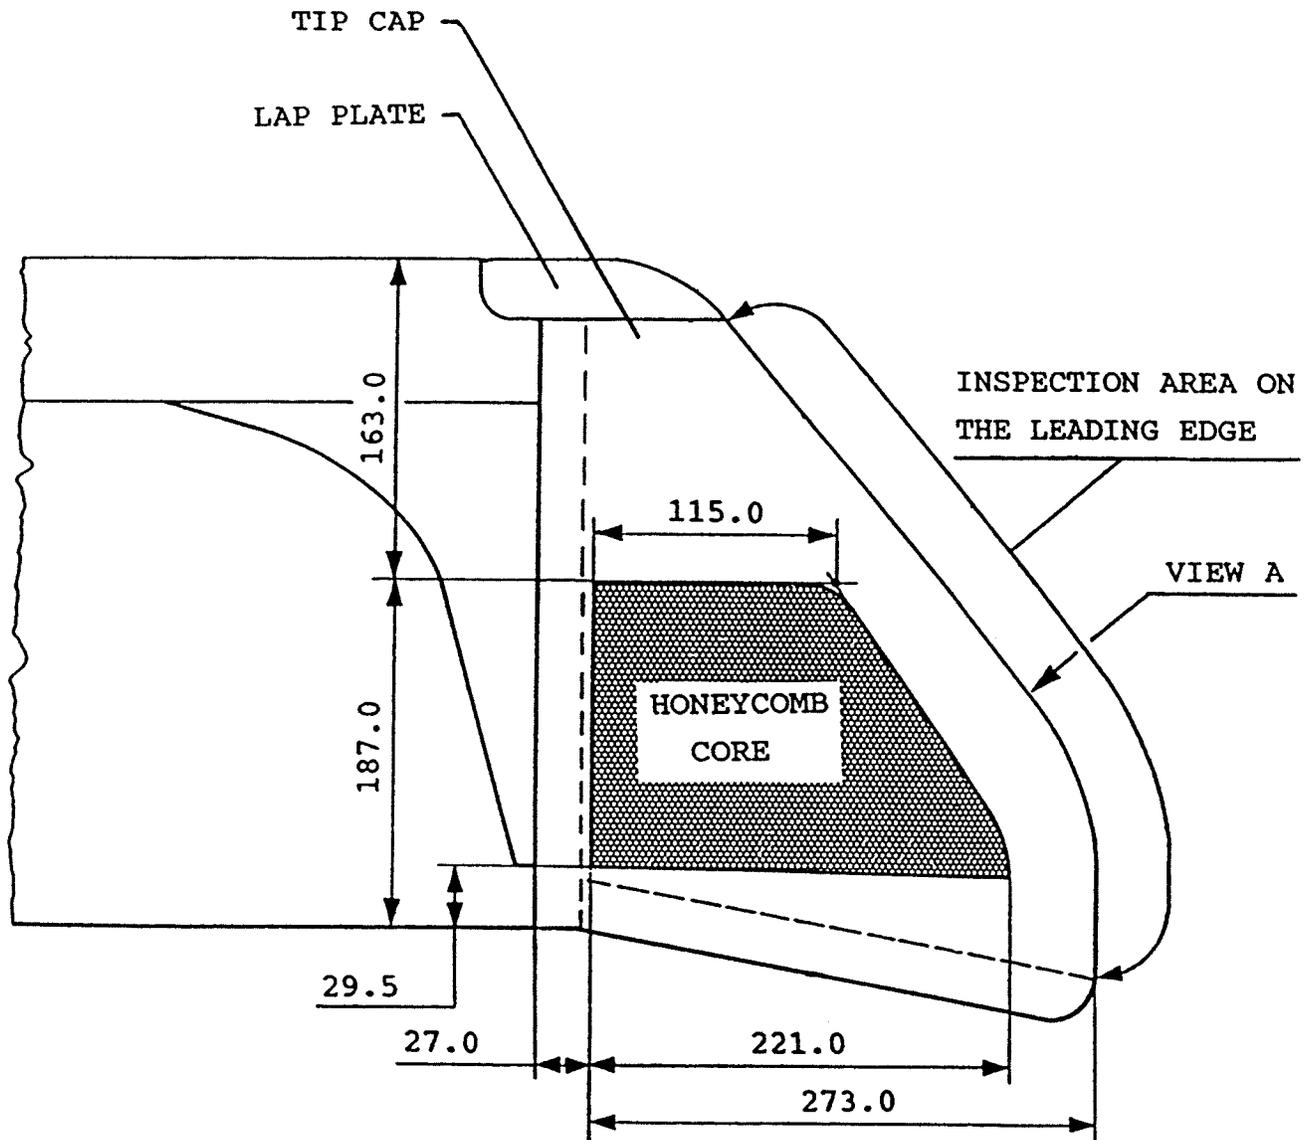
FIGURE 1

(a) Conduct a tap inspection of the upperside and lowerside of each blade tip cap for debonding between the metal shells and the honeycomb core using a steel hammer, P/N 109-3101-58-1, or a coin (a quarter) in the area indicated as honeycomb core on Figure 1.

(c) Using an 8-power or higher magnifying glass, visually inspect the welded bead along the leading edge of each blade tip cap for cracks in the area shown in Figure 1.

(d) If any swelling, deformation, crack, or debonding that exceeds the prescribed limits in the applicable maintenance manual is found, replace the blade with an airworthy blade.
