Federal Register

Monday, June 25, 2001

#### 14 CFR Part 39

#### Airworthiness Directives; Bell Helicopter Textron Canada Model 206L-4 Helicopters

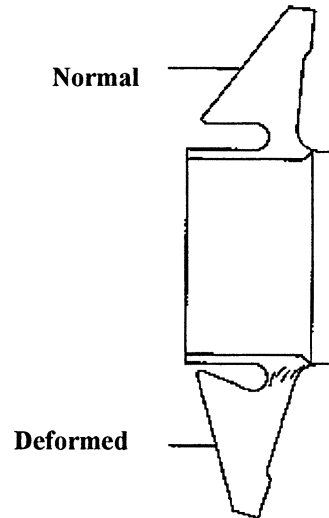
**Figure 1**

**Normal and Deformed (damaged) Indications of the High Altitude Tail Rotor Static Stop Yield Indicator (P/N 206-011-752-101)**

(b) Before each engine start, check the indicator for damage in accordance with Figure 1 of this AD. If damage is found, before further flight, replace the damaged indicator with an airworthy indicator, and replace the tail rotor yoke, P/N 406-012-102-107, with an airworthy tail rotor yoke.
