[Docket No. NHTSA 2001–11041; Notice 1]

Toyota Motor Corporation; Receipt of Application for Decision of Inconsequential Noncompliance

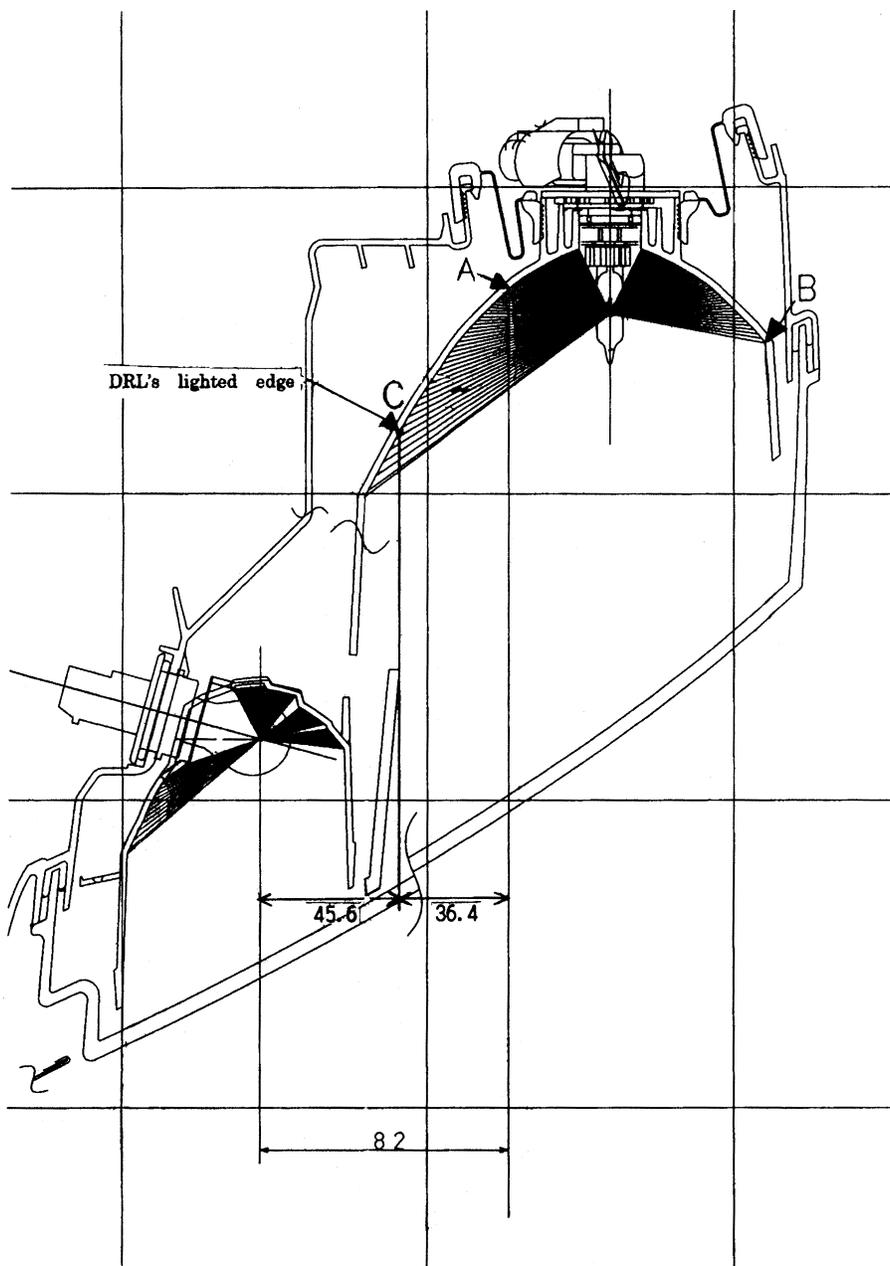
The DRLs on the Celica are provided by the upper beam headlamps operating at a lower intensity, with each lamp having a maximum luminous intensity of roughly 5,880 candelas at test point H–V (as described in FMVSS No. 108 test procedures). S5.5.11(a)(4) of FMVSS No. 108 requires that “* * * if not optically combined with a turn signal lamp, (the DRL) (shall be) located so that the distance from its lighted edge to the optical center of the nearest turn signal lamp is not less than 100 mm, unless * * * the luminous intensity of the DRL is not more than 2,600 candela any location in the beam. * * *” However, for the noncompliant Celicas the distance from the DRL’s lighted edge to the optical center of the nearest turn signal lamp is only 45.6 mm and therefore, the DRLs exceed the maximum luminous intensity specified in section 5.5.11(a)(4)(i) of FMVSS 108.

The substantial distance from the turn signal optical center (bulb filament axes) to the DRL’s lighted edge is 82 mm, exceeding 80% of the requirements. In this case, the “substantial” distance refers to the distance from the turn signal’s optical center to the actual lighted edge “A” (as given by the Figure below), although the theoretical lighted edge is point “C” (45.6mm). In the Figure, the lighted range from A to C of the reflector emits only light which is parallel to the axis of the DRL, which can only be seen by drivers in oncoming vehicles that are looking along the optical axis of the DRL. However, as one moves off center, this light is no longer visible. Therefore, the perceptible DRL’s lighted area, except for the unique case where the eye-point is on the optical axis of the DRL, is actually from A to B (as given in the Figure).
