[Docket No. 2001-SW-67-AD; Amendment 39-12710; AD 2002-08-03]

Airworthiness Directives; Enstrom Helicopter Corporation Model F-28, F-28A, F-28C, F-28F, 280, 280C, 280F, and 280FX Helicopters

ACTION: Final rule; request for comments.

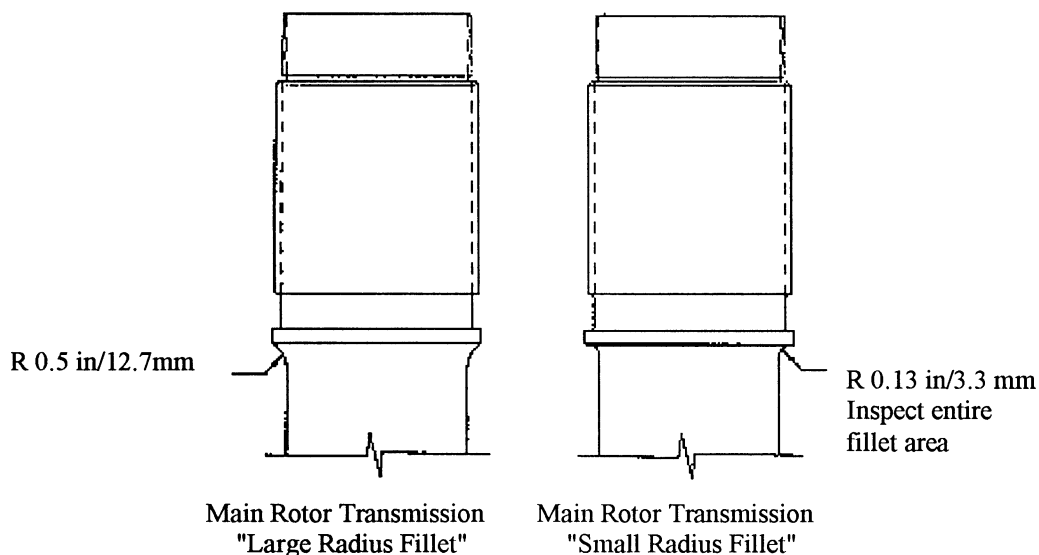
Figure 1. Main Rotor Shaft Inspection

Since the issuance of AD 2001-22-01, Amendment 39-12479, the FAA received a comment that the AD should have cited additional part numbers (part number (P/N) 28-13101-3 and P/N 28-13101-3-R) in Table 1 of the AD. Further, Figure 1 of AD 2001-22-01 contained an error—"2.7mm" is now corrected to state "12.7mm". This AD also corrects another part number and other minor typographical errors. Also, since the issuance of the previous AD, the manufacturer has revised its service information and issued Enstrom Helicopter Corporation Service Directive Bulletin No. 0094, Revision 2, dated February 15, 2002.

(a) Before further flight, determine the part number (P/N) of the main rotor transmission (transmission) and the radius of the upper fillet of the shaft (as shown in the following Figure 1):

(b) For EHC Model F-28C, F-28F, 280C, 280F, and 280FX helicopters, before further flight, replace any transmission having a small radius shaft fillet with an airworthy transmission having a large radius shaft fillet as specified in Table 1 of this AD.

(1) If the transmission has a shaft with a small radius fillet and the transmission P/N is not listed in Table 1, before further flight, replace the transmission with an airworthy

(2) If the installed transmission is P/N 28-13101-1 or -1-R, or P/N 28-13101-3 or -3-R, and has a small radius shaft, before further flight and thereafter at intervals not to exceed 25 hours TIS, visually inspect each transmission for a crack in the shaft upper fillet using a 10X or higher magnifying glass.

(i) If there is any indication of a crack, before further flight, a level II nondestructive inspector must dye-penetrant inspect the shaft using materials approved by MIL-I-25135.

(ii) If the shaft is cracked, before further flight, replace the transmission with an airworthy transmission having a large radius shaft fillet.

(3) If the transmission is P/N 28-13101-1 or -1-R, or P/N 28-13101-3 or -3-R, within 5 hours TIS, and thereafter at intervals not to exceed 100 hours TIS:

(i) Dye-penetrant inspect the shaft upper fillet for a crack, a nick, or a scratch.

(ii) Polish out nicks or scratches less than 0.005-inch deep.

(iii) If the shaft is cracked or has a nick or scratch 0.005 inch or more deep, replace the transmission with an airworthy transmission having a large radius shaft fillet before further flight.

(4) Within 300 hours TIS or at the next overhaul after the effective date of this AD, whichever occurs first, replace transmission, P/N 28-13101-1 or -1-R, or P/N 28-13101-3 or -3-R, with an airworthy transmission having a large radius shaft fillet.
