[Docket No. 2002-SW-04-AD; Amendment 39-12736; AD 2002-09-03]

#### **Airworthiness Directives; Eurocopter France Model AS332L2 Helicopters**

##### 2002-09-03 Eurocopter France:

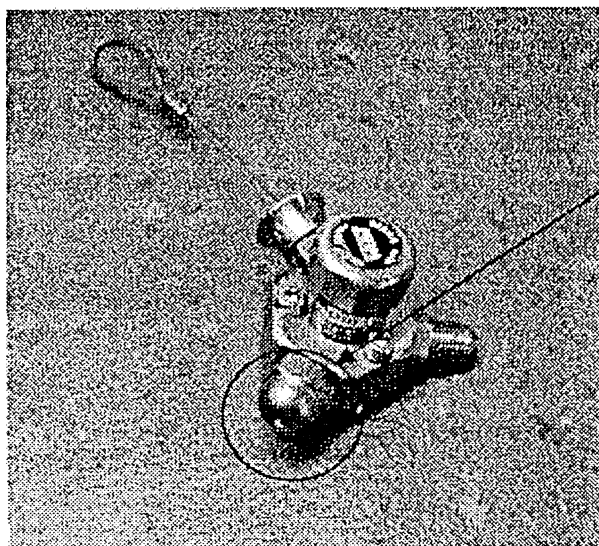
DETAIL 1

(a) Verify that the air vent is installed on the head of the inflation cylinder of each lift raft assembly as shown in FIGURE 1:

AIR VENT INSTALLED

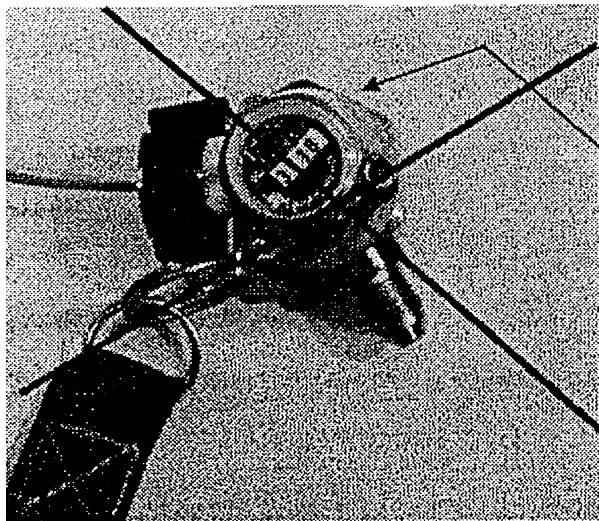
DETAIL 1

**SUPPLEMENTARY INFORMATION:** The Direction Generale De L'Aviation Civile (DGAC), the airworthiness authority for France, notified the FAA that an unsafe condition may exist on ECF Model AS332L2 helicopters. The DGAC advises of the discovery of a missing air vent on the head of the inflation cylinder of a life raft. Absence of an air vent on the cylinder head might lead to inadvertent life raft inflation and cause

AIR VENT NOT INSTALLED

If the air vent is missing, replace the cylinder head with an airworthy cylinder head before further flight.
