**DEPARTMENT OF TRANSPORTATION**

**Federal Aviation Administration**

[Docket No. 2002–SW–15–AD; Amendment 39–12817; AD 2002–14–17]

**Airworthiness Directives; Eurocopter Deutschland GmbH Model EC135 Helicopters**

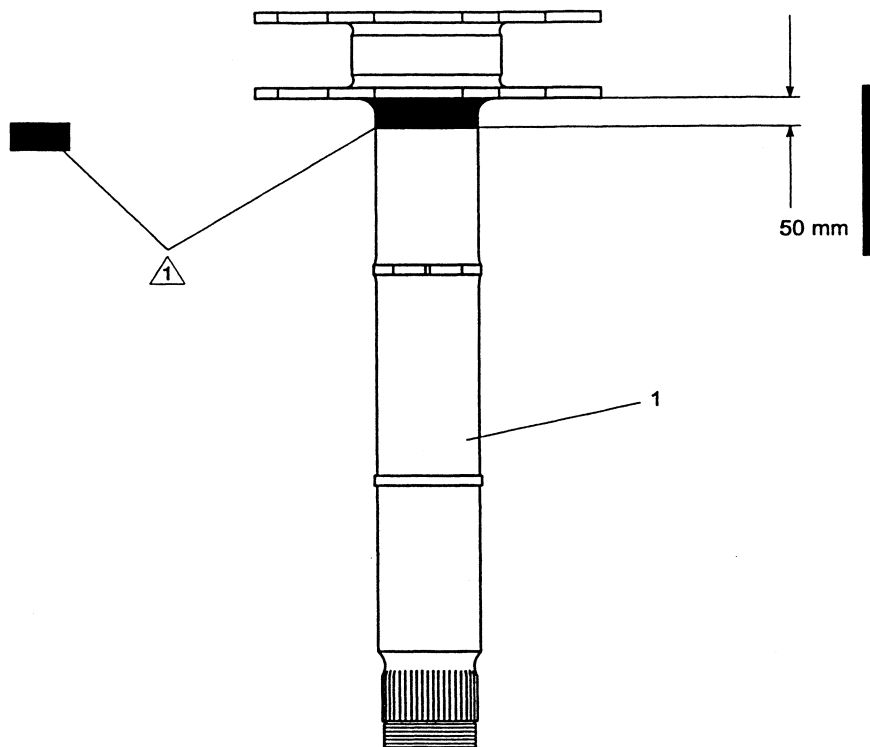
Crack inspection on main rotor hub-shaft  
Figure 1

for using either a visual or dye-penetrant inspection to satisfy the repetitive inspection requirement. This amendment is prompted by the need to correct the shaft part number and increase the area of inspection, as well as add additional affected shaft P/N's. The actions specified by this AD are intended to detect fatigue cracks in the shaft that could lead to shaft failure and subsequent loss of control of the helicopter.

△ 1 Inspect marked area i.a.w. crack inspection procedure described.

1 Main Rotor Hub-Shaft

(a) Before further flight, clean and visually inspect the shaft for cracks in the area as shown in the following Figure 1:

(b) Within 10 hours time-in-service (TIS) after accomplishing the visual inspection required by paragraph (a) of this AD, clean and dye-penetrant inspect the shaft for cracks in the area as shown in Figure 1 of this AD.

(c) Thereafter, visually inspect the shaft for cracks in accordance with paragraph (a) of this AD at intervals not to exceed 15 hours TIS, or dye-penetrant inspect the shaft for cracks in accordance with paragraph (b) of this AD at intervals not to exceed 100 hours TIS.

(d) If a crack is discovered during any shaft inspections, remove the shaft and replace it with an airworthy shaft.
