#### Airworthiness Directives; Bell Helicopter Textron Canada Model 407 Helicopters

**ACTION:** Notice of proposed rulemaking (NPRM).

**Bell Helicopter Textron Canada:** Docket No. 2001-SW-53-AD. Supersedes AD 2000-06-10, Amendment 39-11651, Docket No. 99-SW-75-AD.

**Applicability:** Model 407 helicopters, serial number (S/N) 53000 through 53475 with tailboom, part number (P/N) 407-030-801-101, -105, or -107, installed, certificated in any category.

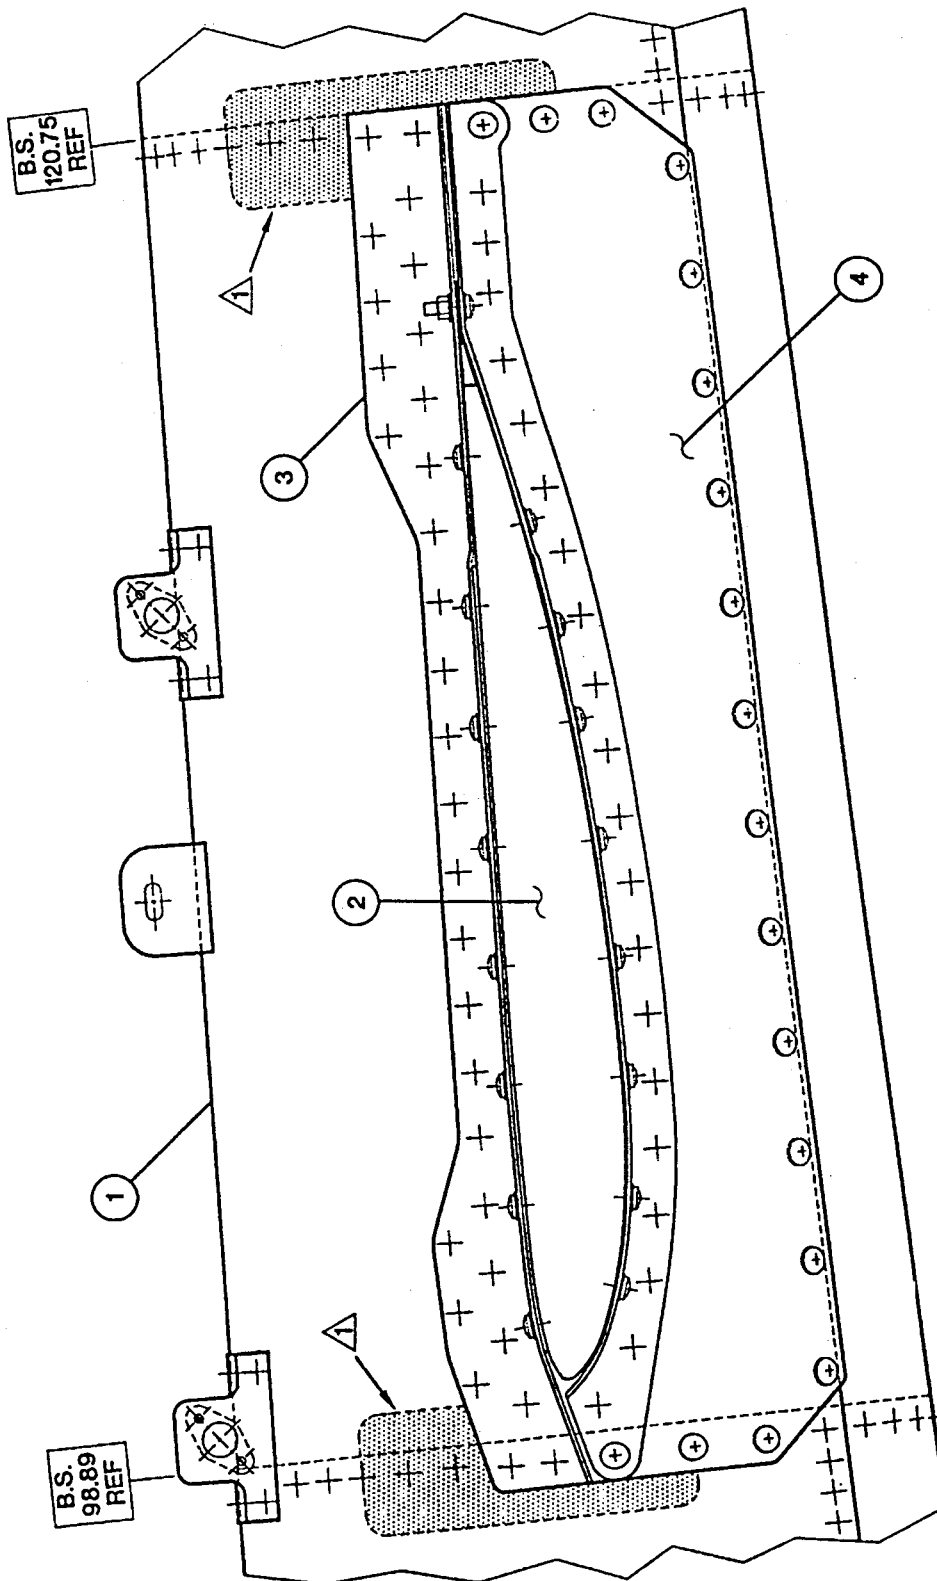
**Figure 1. Preflight Check of the Tailboom**

On March 21, 2000, the FAA issued AD 2000-06-10, Amendment 39-11651 (65 FR 16804, March 30, 2000), to require preflight checking and repetitively inspecting the tailboom for a crack and replacing the tailboom if a crack is found. That action was prompted by four reports of cracks on the tailboom in the area of the horizontal stabilizer. The requirements of that AD are intended to prevent

1. Examine these areas for cracks on left side of tailboom only.
2. Horizontal stabilizer not shown for clarity.

(a) Before further flight and thereafter before the first flight of each day, check the tailboom for a crack in accordance with Figure 1 of this AD. If a crack is found,

remove the tailboom before further flight. An owner/operator (pilot) holding at least a private pilot certificate may perform the visual check required by this paragraph but must enter compliance with this paragraph into the helicopter records in accordance with 14 CFR 43.11 and 91.417(a)(2)(v). A pilot can perform this check because it involves only a visual check for a crack in the tailboom and is a part of a normal pilot preflight check.
