[Docket No. 2002-SW-22-AD; Amendment 39-12835; AD 2002-08-54]

Airworthiness Directives; Bell Helicopter Textron Canada Model 222, 222B, 222U, and 230 Helicopters

2002-08-54 Bell Helicopter Textron

Canada: Amendment 39-12835, Docket No. 2002-SW-22-AD.

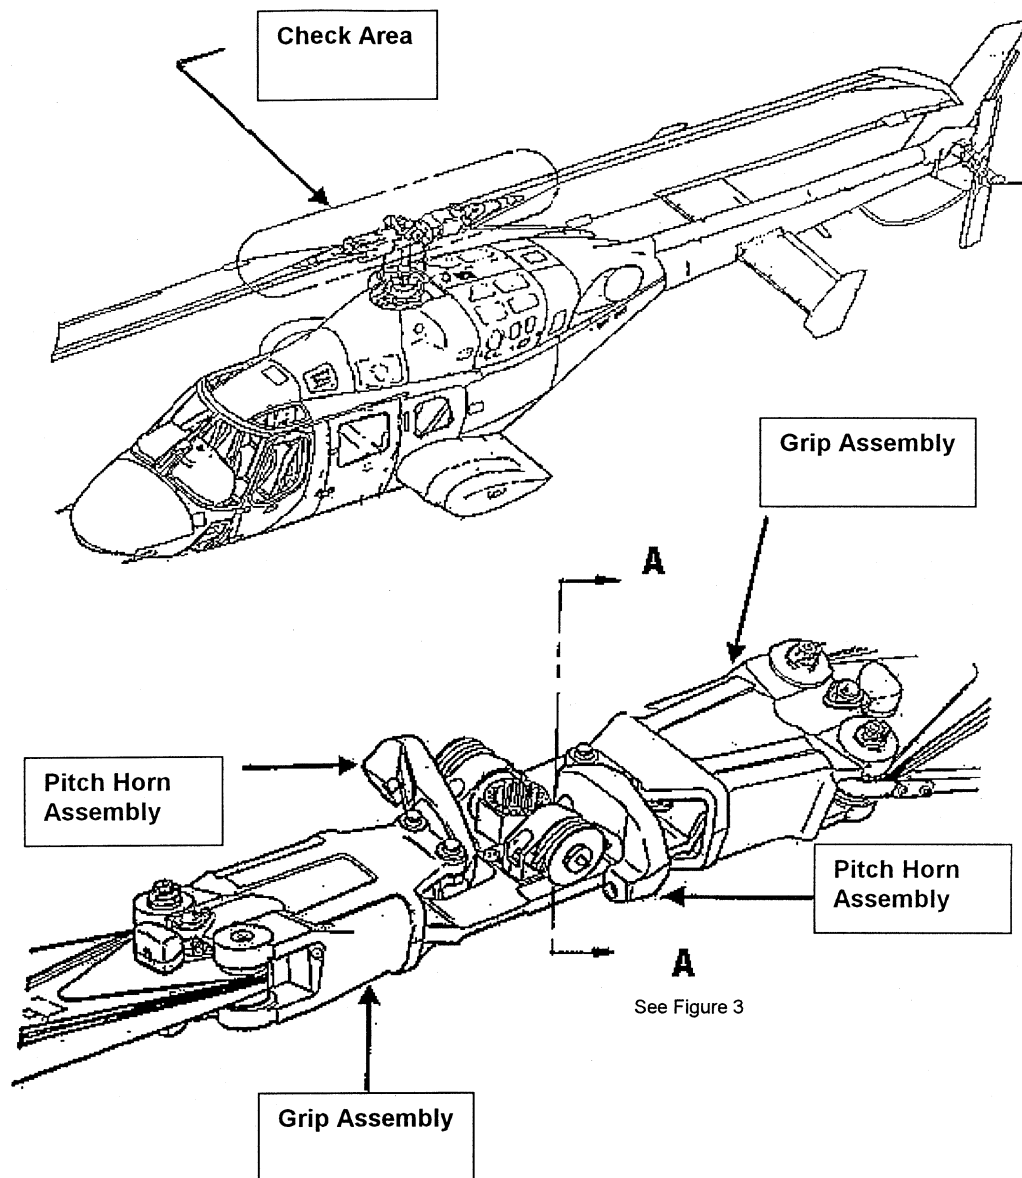
(1) Wipe clean the main rotor grip and pitch horn surfaces to remove grease and dirt in the check area as shown in Figure 1 of this AD:

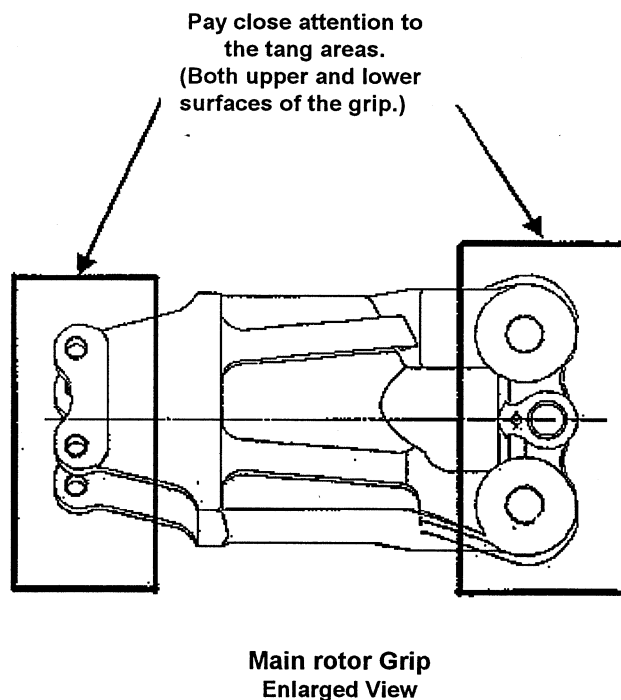
(2) Visually check both main rotor grips for a crack, paying particular attention to the inboard and outboard tangs/portions of the grip, which are in direct contact with the pitch horns and the main rotor blades. Check the area to at least 3 inches beyond the grip/pitch and grip/blade contact areas as shown in Figure 2 of this AD:

Check entire surface of the grip.

(c) If a crack is found, replace the unairworthy grip or pitch horn with an airworthy part before further flight.

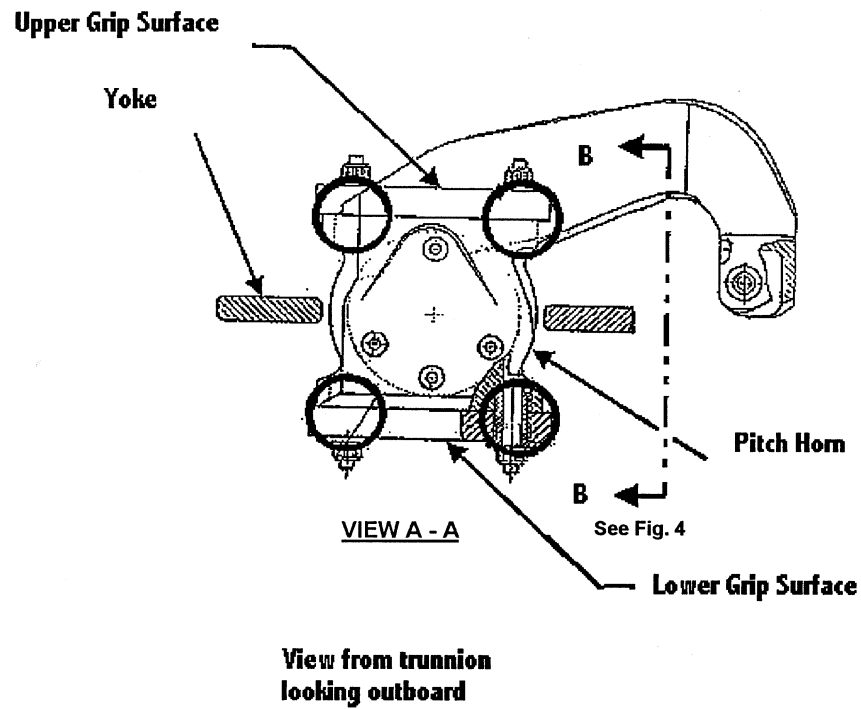
(3) Visually check all visible portions of each pitch horn for a crack. Pay particular attention to the attachment lugs of the pitch horns, which are in direct contact with the inboard tangs of the main rotor grips, as shown in Figure 3 of this AD, and the four large bolt cutouts, as shown in Figure 4 of this AD:

**All visible portions of the pitch horn must be checked.
Pay particular attention to the circled areas shown above and View B-B, Fig. 4.**
