[Docket No. 2002–NM–130–AD; Amendment 39–12840; AD 2002–16–01]

Airworthiness Directives; McDonnell Douglas Model DC–8–21, –31, –32, –33, –41, –42, and –43 Airplanes; and Model DC–8–50, –60, and –70 Series Airplanes; Modified per Supplemental Type Certificates SA1063SO, SA1862SO, or SA1832SO

ACTION: Final rule; request for comments.

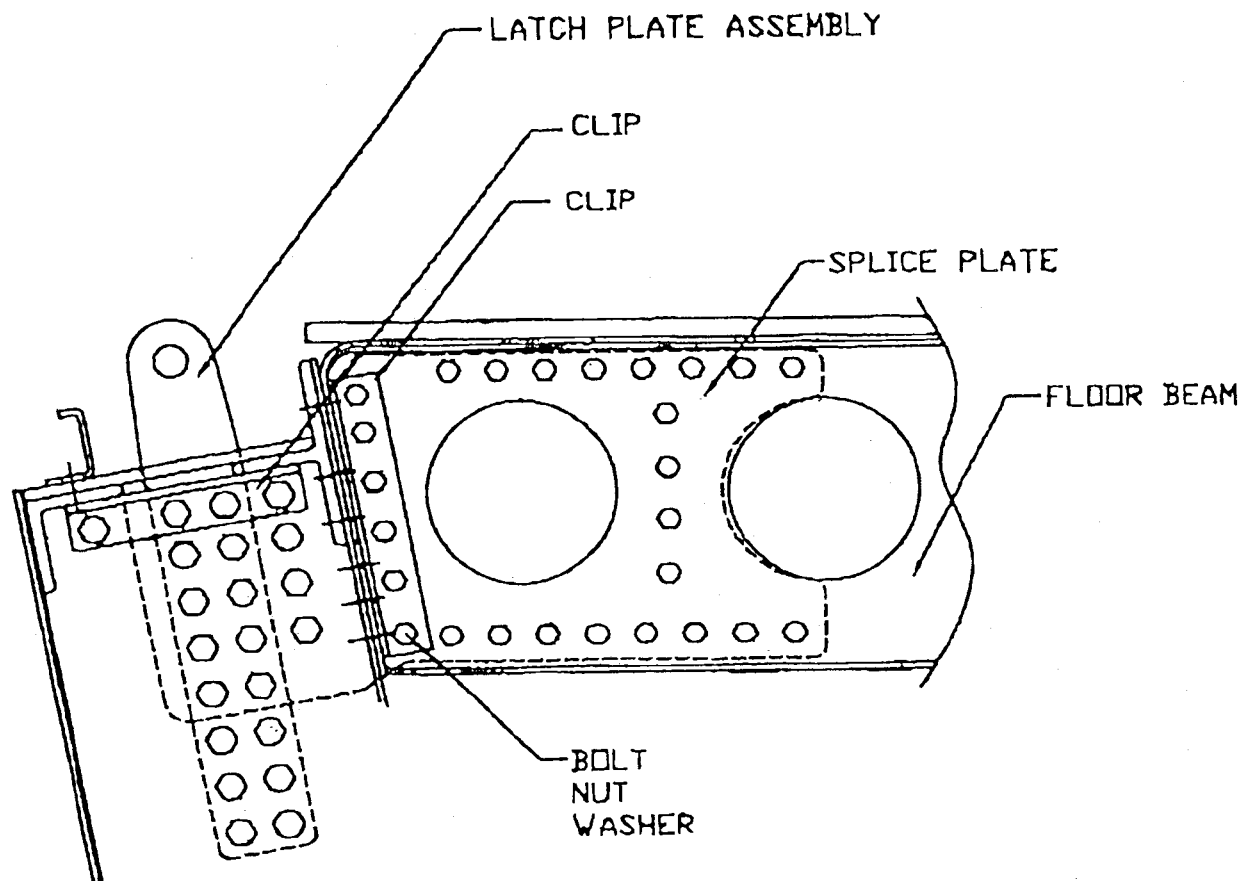
Figure 1.

Since an unsafe condition has been identified that is likely to exist or develop on other airplanes of the same type design, this AD is being issued to prevent failure of the floor beam attachments to the lower door jamb. Such failure could cause damage to the floor structure and consequent jamming of the flight control cables, and result in loss of controllability of the airplane in flight. This AD requires gaining access to the floor beam attachments to the lower door jamb within the main cargo door area; and performing repetitive inspections to detect cracking or damage of such attachments, including splice plates, angles, and clips. If any cracking or damage is found, this AD also requires extending the area of inspection 60 inches forward and aft of the main cargo door area, and replacing any cracked or damaged part with a new part. Figure 1 of Appendix 1 of this AD identifies the inspection area and parts to be inspected.

(2) Perform a detailed inspection of the main cargo door area to detect any cracking or damage of the floor beam attachments to the lower door jamb, including the splice plates, angles, and clips identified in Figure 1 of Appendix 1 of this AD. Thereafter, repeat the inspection at intervals not to exceed 2,500 flight cycles or 18 months, whichever occurs earlier.

(b) If any cracking or damage is found during any inspection required by paragraph (a)(2) of this AD, before further flight, extend the area of inspection 60 inches forward and aft of the main cargo door area, and replace any cracked or damaged part with a new part identified in Figure 1 of Appendix 1 of this AD.
