[Docket No. 2000–SW–55–AD; Amendment 39–12898; AD 2002–20–03]

**Airworthiness Directives; Eurocopter France Model AS332C, L, L1, and L2; AS350B, BA, B1, B2, B3, and D; AS355E, F, F1, F2, and N; AS–365N2; AS 365 N3; SA330F, G, and J; SA–360C; SA–365C, C1, and C2; SA.316B and C; and SA.319B Helicopters**

#### 2002–20–03 Eurocopter France:

Amendment 39–12898. Docket No. 2000–SW–55–AD.

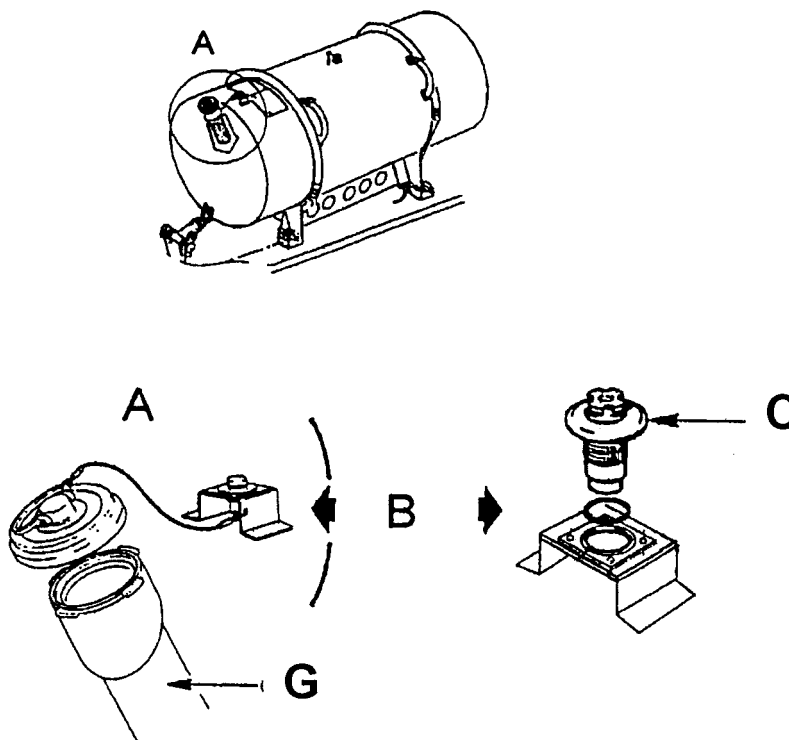
FIGURE 1 FERRY FUEL TANK

To prevent refueling a tank that is not adequately electrically bonded, which could generate an electric arc between the refueling nozzle and the tank, causing a fuel tank explosion, accomplish the following:

(a) Measure the electrical resistance between the tank electrostatic ground connector (item C) and the tank filler neck (item G) as shown in Figure 1 of this AD. If the value of the electrical resistance is more than 1.5 milliohms, refueling the tank is prohibited. See Figure 1 as follows:
