[Docket No. 2000-CE-44-AD; Amendment 39-12920; AD 2002-21-13]

#### Airworthiness Directives; Raytheon Aircraft Company Beech Models 35, 35R, A35, and B35 Airplanes

**ACTION:** Final rule.

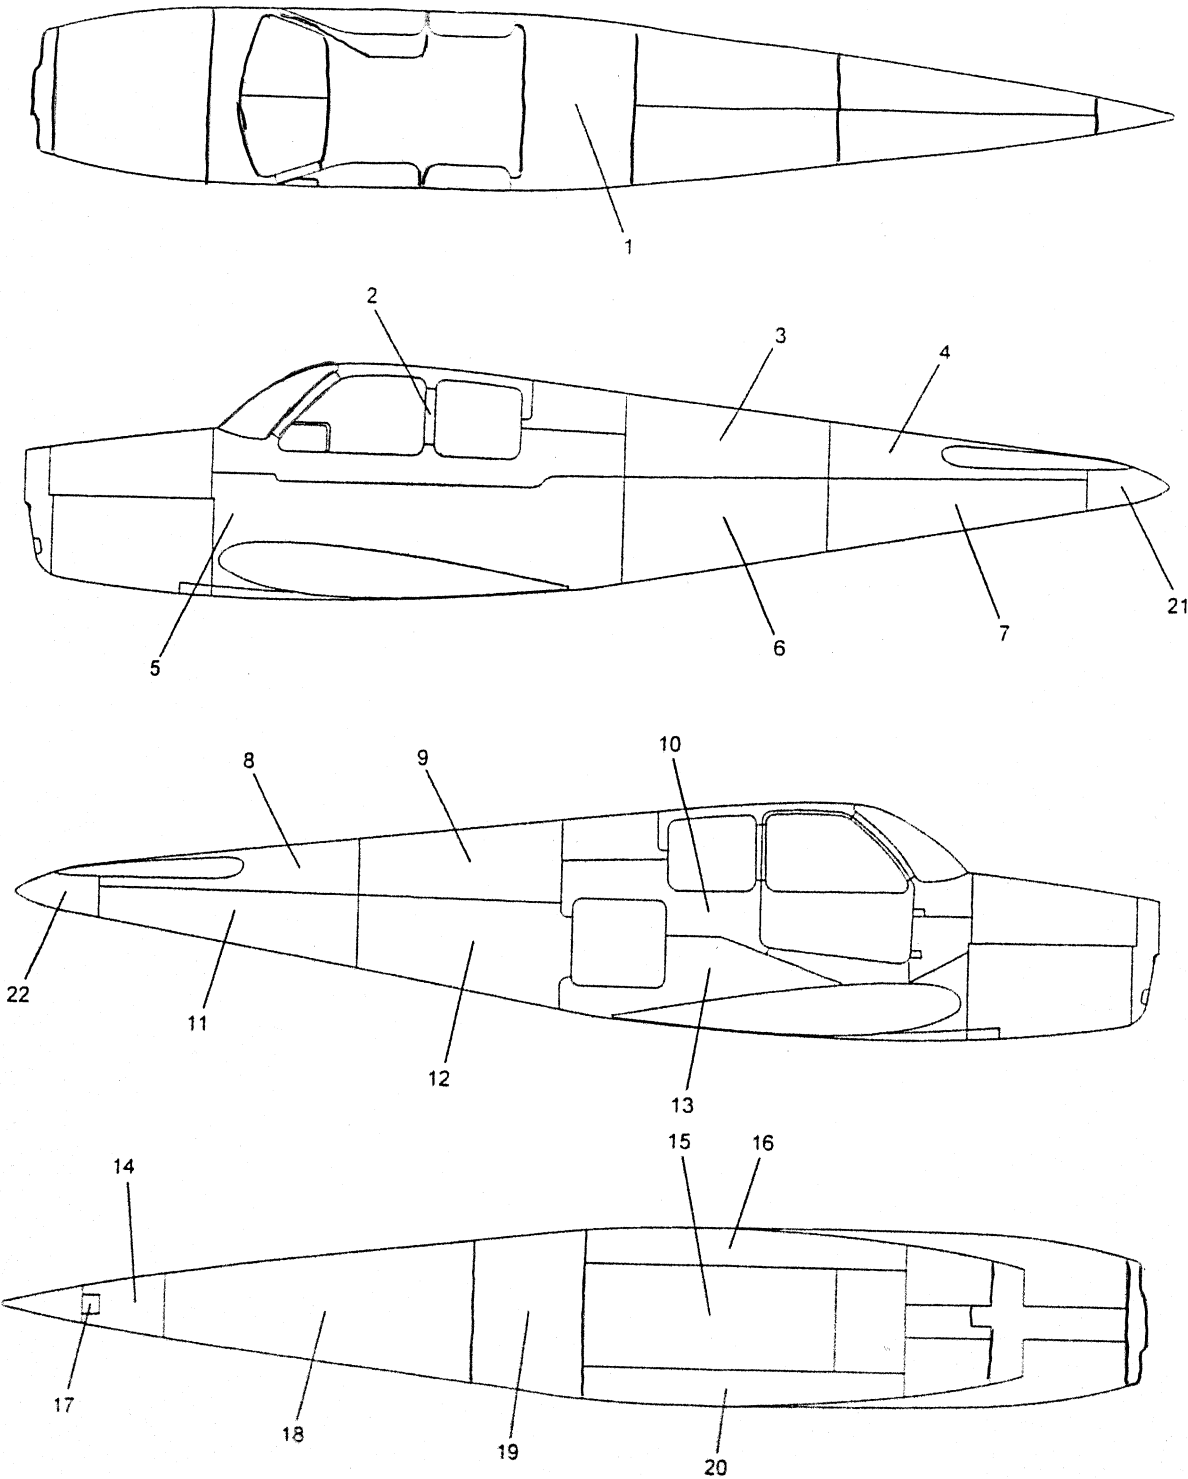
Figure 1

| Actions | Compliance | Procedures |
|---|---|---|
| (5) Visually inspect the empennage, aft fuselage, and ruddervator control system for damage:<br>(i) Part of this is an inspection of the aft fuselage skin for wrinkles or cracks. Specific skin thicknesses are presented in Figures 1 and 2 of this AD. The skin thickness measurement is not repetitive.<br>(ii) The inspection and setting of the travels on the elevator and elevator trim tabs are not repetitive.<br>(iii) Repair or replace any damaged parts and set the elevator controls, rudder and tab system controls, cable tensions, and rigging. | Inspect within the next 100 hours TIS after the last inspection required by AD 94-20-04 or within the next 25 hours TIS after December 10, 2002 (the effective date of this AD), whichever occurs later, and thereafter at intervals not to exceed 100 hours TIS, except for the skin thickness measurement and the inspection and setting of the travels on the elevator and elevator trim tabs, which are one-time actions. Accomplish any repairs, replacements, and adjustments prior to further flight after the applicable inspection. | Accomplish the inspection and repairs or replacements in accordance with the procedures in paragraphs (5)(a) through (5)(f) of the ACCOMPLISHMENT INSTRUCTIONS section of Raytheon Service Bulletin No. SB 27-3358, Issued: February, 2000, and use a digital ultrasonic skin tester or equivalent skin tester or direct methods that utilize calipers and micrometers. Specific skin thicknesses are contained in Figures 1 and 2 of this AD. |

Skin Thickness – Raytheon Aircraft (Beech) Models 35, 35R, A35, and B35
