[Docket No. 2004-SW-04-AD]

Airworthiness Directives; Bell Helicopter Textron Canada Model 222, 222B, 222U, and 230 Helicopters

ACTION: Notice of proposed rulemaking (NPRM).

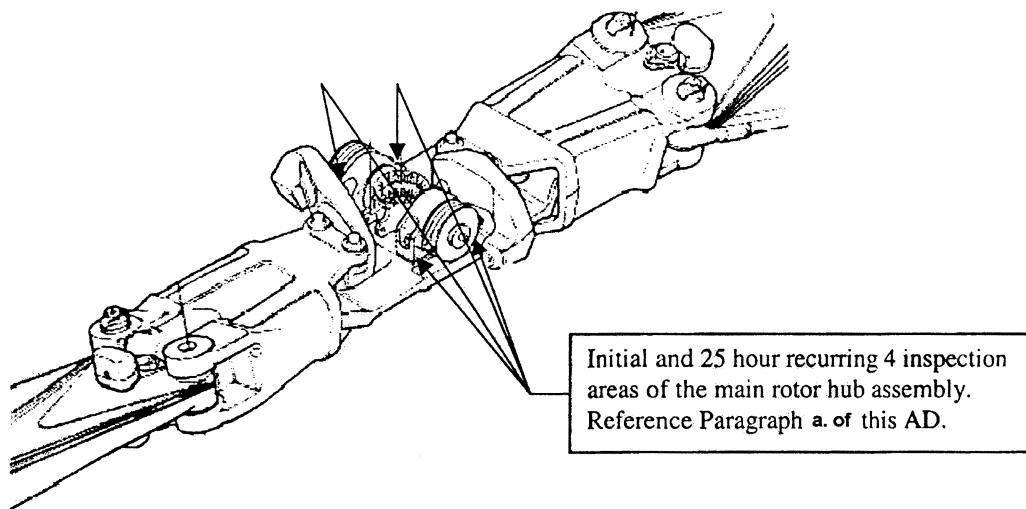
Figure 1. Main Rotor Hub Assembly

(a) Within 50 hours time-in-service (TIS) or by the next scheduled inspection for the hub assembly, whichever occurs first, and thereafter at intervals not to exceed 25 hours TIS, using a 10X or higher magnifying glass, visually inspect the main rotor yoke (yoke)

for a crack, fretting or buffer deterioration in the four areas around the flapping bearing attachment bushings as shown in the following Figure 1 of this AD:

(1) If a crack is found, before further flight, replace the yoke with an airworthy yoke.

(2) If fretting or buffer deterioration is found on the yoke in the areas shown in Figure 1 of this AD, before further flight, disassemble the hub assembly and further inspect the yoke with a 10X or higher magnifying glass in the four areas shown in Figures 2 and 3 of this AD.

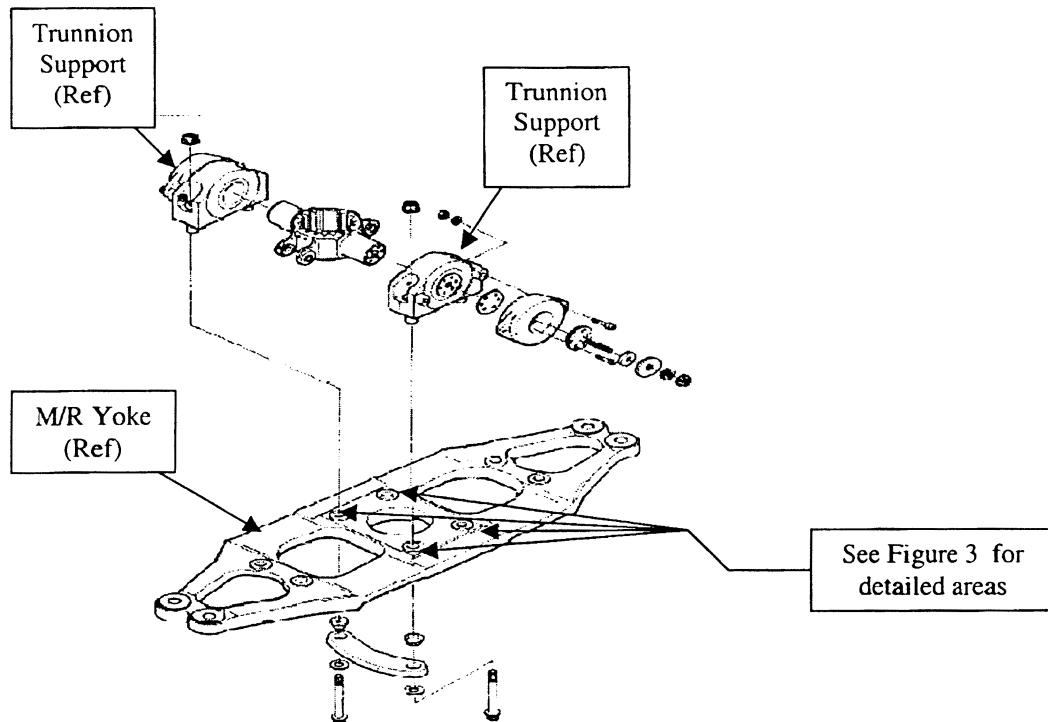
Figure 2. Main Rotor Yoke

Shown with trunnion supports removed.

(i) If a crack is found on any part, before further flight, replace the part with an airworthy part.

(ii) If fretting or buffer deterioration is found on any part, before further flight, repair any unairworthy part or replace the part with an airworthy part.
