[Docket No. FAA-2005-22026; Directorate Identifier 2005-SW-05-AD; Amendment 39-14210; AD 2005-16-05]

#### Airworthiness Directives; Robinson Helicopter Company Model R-22 Series Helicopters

**2005–16–05 Robinson Helicopter Company:** Amendment 39–14210. Docket No. FAA–2005–22026; Directorate Identifier 2005–SW–05–AD.

*Applicability:* Model R–22 series helicopters, modified with a door assembly manufactured by Tech-Tool Plastics, Inc., in accordance with STC No. SR09189RC, certificated in any category.

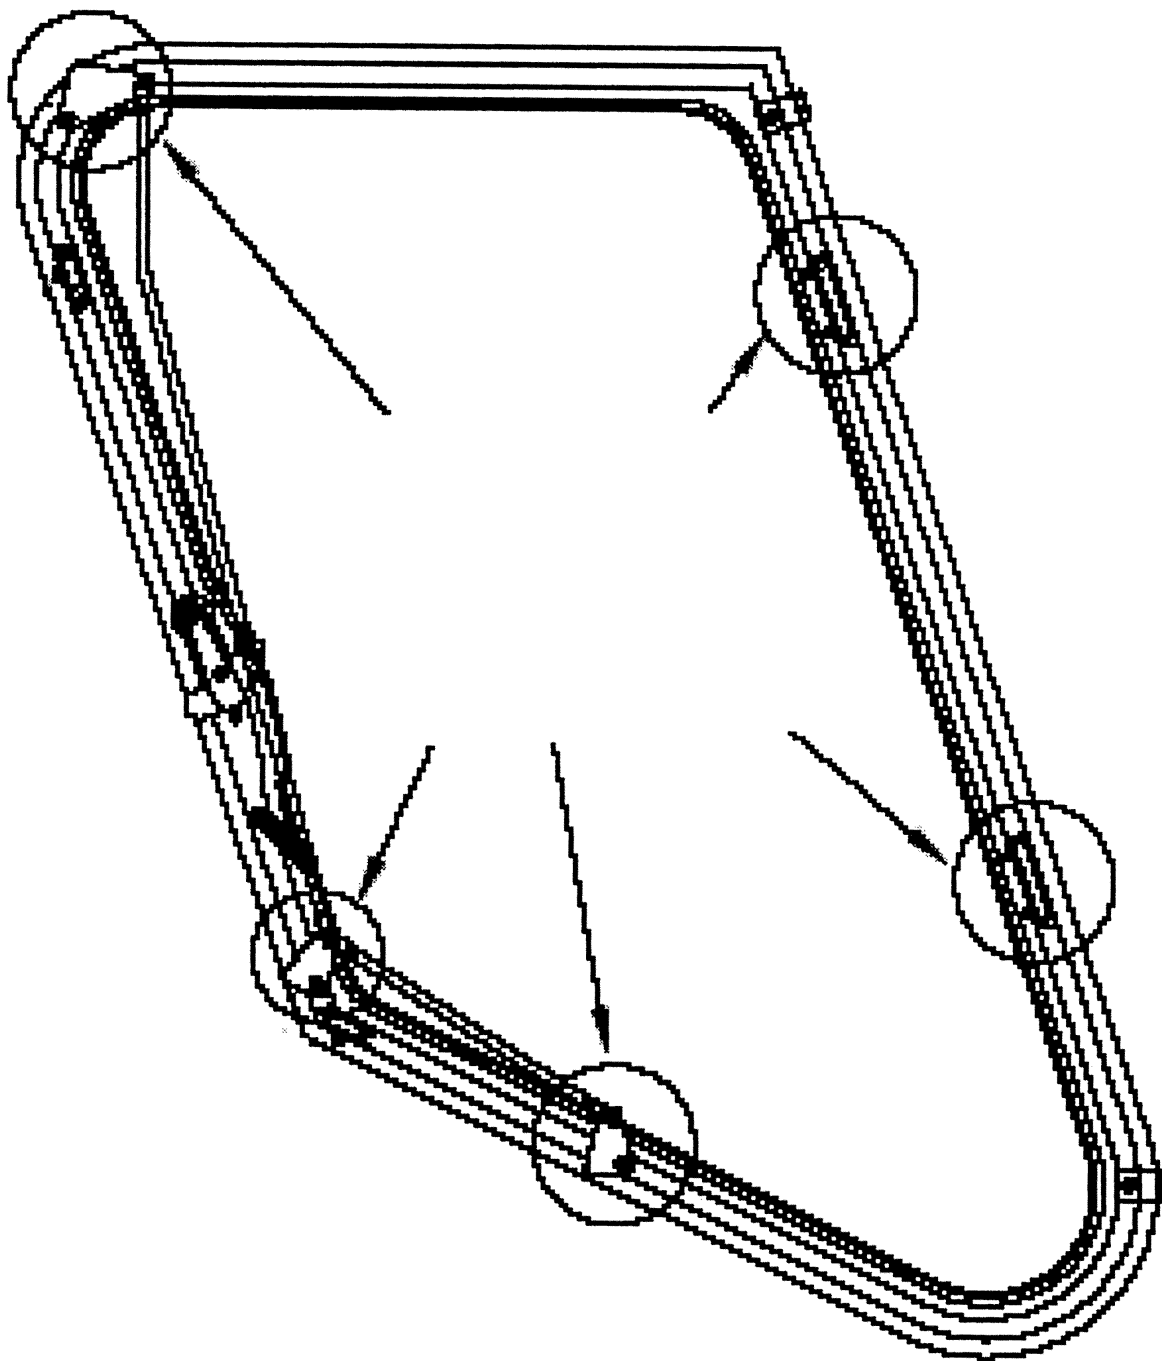
**Figure 1**

Subsequent investigation revealed cracking across the composite door assembly integral frame stiffener bead, just beneath the lower hinge on the forward edge of the door, and at the upper and lower door cam lock on the trailing edge of the door. Further investigation revealed that the door weather seal set was not the weather seal set supplied by the door assembly manufacturer. Additionally, the two nylon adjustment screws, which are required to relieve excessive force on the door hinges, were broken or missing. Finally, the door may not have been trimmed to the cabin door opening as stated in the manufacturer's door assembly installation drawings. The actions specified in this AD are intended to prevent separation of a door window or door assembly from the helicopter, which could damage the tail rotor during flight and result in loss of control of the helicopter.

(1) Visually inspect each pilot and copilot door assembly integral frame for a crack in the locations depicted in Figure 1 of this AD. If a crack is found, before further flight, replace the cracked door assembly, part number (P/N) R–22–101–51 or P/N R–22–101–53 (left-hand door assembly), or P/N R–22–101–52 or P/N R–22–101–54 (right-hand door assembly), with an airworthy door assembly. If you use door assembly, P/N R–22–101–51 or P/N R–22–101–53 (left-hand door assembly), or P/N R–22–101–52 or P/N R–22–101–54 (right-hand door assembly) as the replacement, then install it in accordance with Tech-Tool Plastics, Inc. Installation Instructions TTP–1R, Revision A, dated November 21, 1997, and with the sections titled “Door Weather Seal Installation” and “Cotter Pin Installation” in Tech-Tool Plastics, Inc. Service Bulletin No. TTP2005–01, Revision A, dated February 1, 2005 (SB).

**Door Assembly (left-hand shown) View Looking Outboard**

(b) After accomplishing the inspections in paragraphs (a) through (a)(2)(ii) of this AD, at intervals not to exceed 100 hours time-in-service, visually inspect each pilot and copilot door assembly integral frame for a crack in the locations depicted in Figure 1 of this AD.

(c) If a crack is found, before further flight, replace the cracked door assembly, P/N R-22-101-51 or P/N R-22-101-53 (left-hand door assembly), or P/N R-22-101-52 or P/N R-22-101-54 (right-hand door assembly), with an airworthy door assembly. If the replacement door assembly is P/N R-22-101-51 or P/N R-22-101-53 (left-hand door assembly), or P/N R-22-101-52 or P/N R-22-101-54 (right-hand door assembly), then install it in accordance with Tech-Tool Plastics, Inc. Installation Instructions TTP-1R, Revision A, dated November 21, 1997, and "Door Weather Seal Installation" and "Cotter Pin Installation" sections of the SB.
