[Docket No. FAA-2005-22481; Directorate Identifier 2004-NM-176-AD]

Airworthiness Directives; Bombardier Model CL-600-2B19 (Regional Jet Series 100 & 440) Airplanes

ACTION: Notice of proposed rulemaking (NPRM).

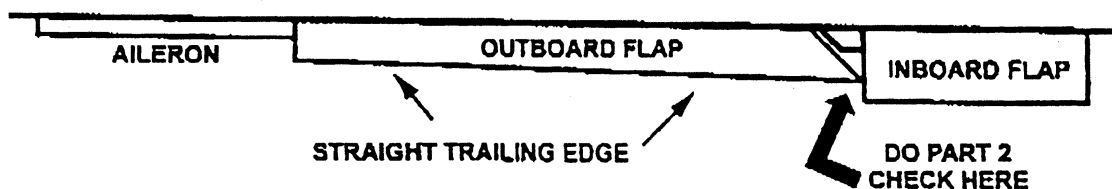
Figure 1. Normal/Abnormal Outboard flap Configuration in Take-off Position"

1. NORMAL

A normal outboard flap has a straight trailing edge, and the inboard corner is slightly above (*i.e.* higher) than the inboard flap.

2. ABNORMAL

The following are indications of an outboard flap with a twist, skew or abnormal deformation:

- Noticeable curve in the trailing edge
- Buckled top or bottom surface
- Higher than normal position of the inboard trailing edge corner

(b) An external visual check must be accomplished to detect any twisting, skewing, or abnormal deformation of the flaps, using the information given in Figures 1 and 2.

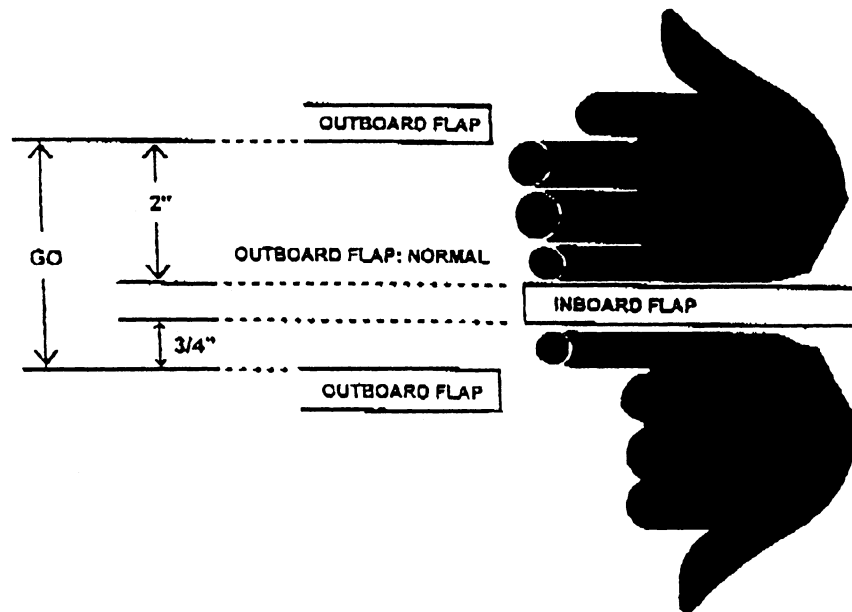
1. FLAPS AT 8 DEGREES

If the outboard flap position is outside the "GO" range as shown below further flight is prohibited.

Whenever the outboard flap position indicator is outside the 'GO' range as shown in Figure 2, or whenever directed to do so by the Maintenance Procedure above, perform the following procedures:
