DEPARTMENT OF TRANSPORTATION

Airworthiness Directives; Bell Helicopter Textron Canada Model 206A, B, L, L-1, L-3, and L-4 Helicopters

ACTION: Notice of proposed rulemaking (NPRM).

Bell Helicopter Textron Canada: Docket No. FAA–2005, Directorate Identifier 2005–SW–22–AD. Supersedes AD 2004–24–08, Amendment 39–13884, Docket No. 2004–SW–12–AD.

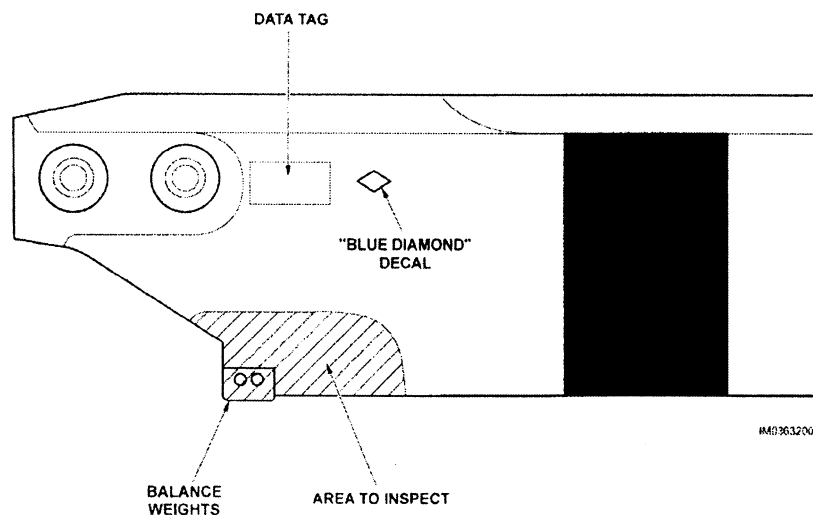
Figure 1. Tail rotor blade inspection.

installing any blade with a P/N and S/N listed in the applicability section of this AD, clean the blade. Using a 10X or higher magnifying glass, inspect both sides of each blade for a deformation, a crack, and a bent

or deformed weight in the area shown in Figure 1 of this AD.

Note 1: Paint irregularities on the blade may indicate a crack.

(1) At intervals not to exceed 12 hours time-in-service (TIS), using a 10X or higher magnifying glass, inspect both sides of each blade for a deformation, a crack, and a bent or deformed weight in the area shown in Figure 1 of this AD, or

(2) Inspect and check both sides of each blade for a deformation, a crack, and a bent or deformed weight in the area shown in Figure 1 of this AD as follows:

(c) Before further flight, replace any blade that has a deformation, a crack, or a bent or deformed weight with an airworthy blade.
