### Airworthiness Directives; Eurocopter France Model SA-360C, SA-365C, SA-365C1, and SA-365C2 Helicopters

#### 2006-08-06 Eurocopter France:

Amendment 39-14561. Docket No. FAA-2006-24446; Directorate Identifier 2005-SW-15-AD.

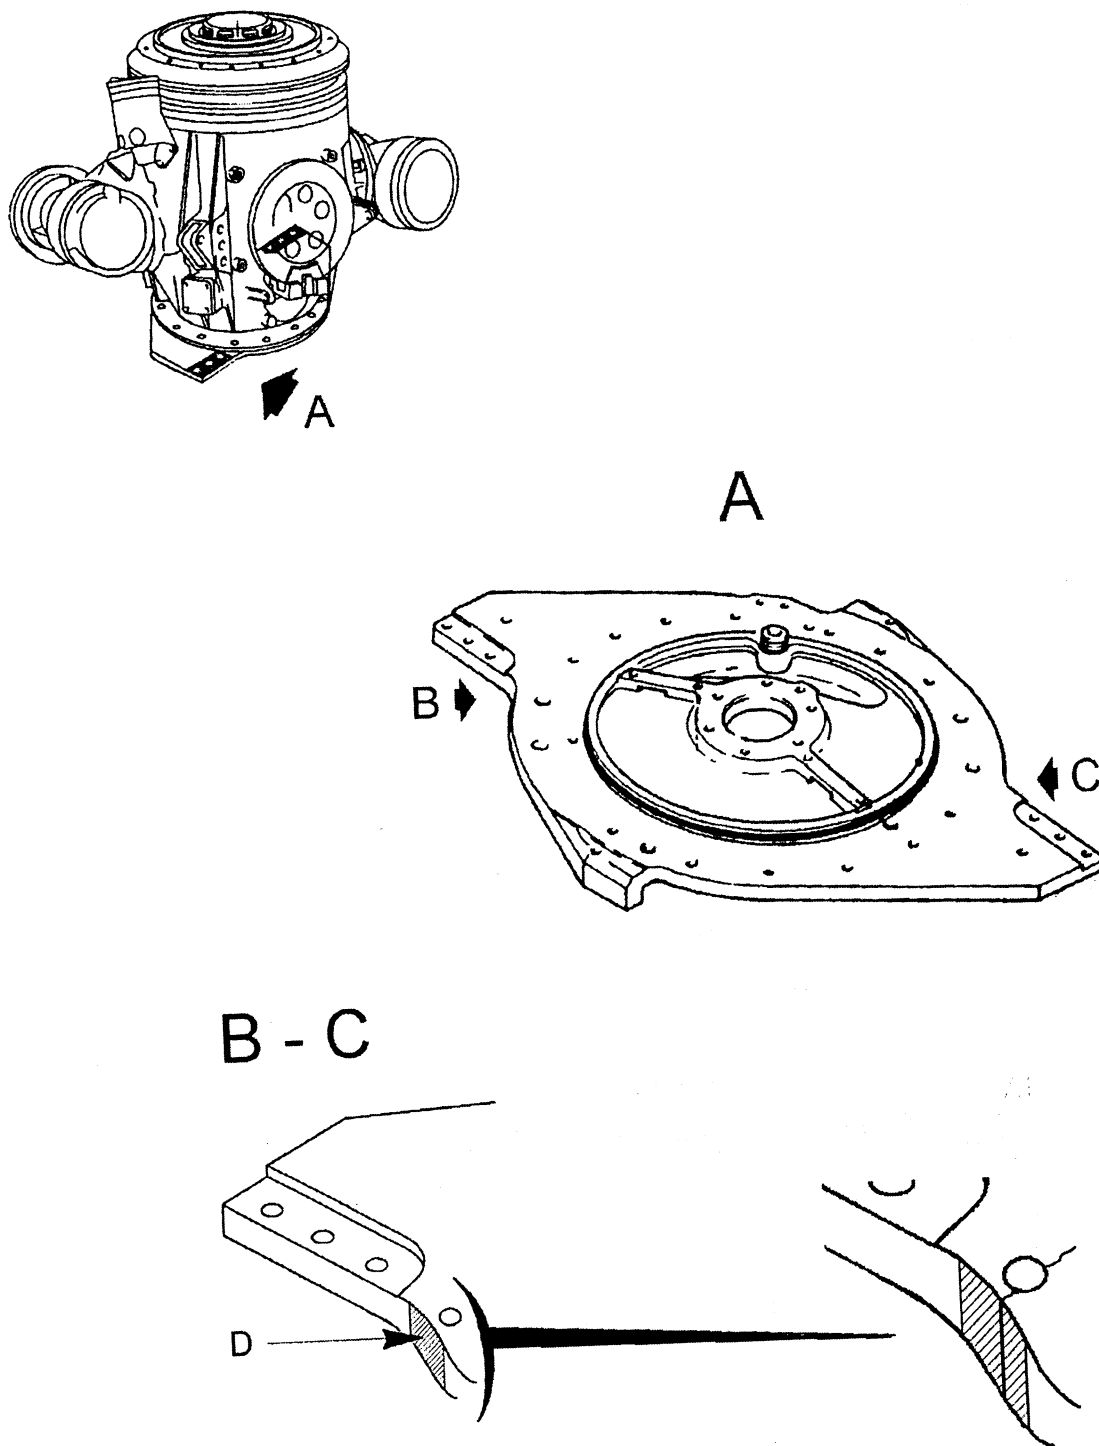
paint from area "D" on both sides ("B" and "C") of the MGB base plate as depicted in Figure 1 of this AD.

(b) At the times indicated in the compliance table, inspect area "D" of the MGB base plate for a crack using a 10x or higher magnifying glass. Area "D" to be inspected is depicted in Figure 1 of this AD.

(c) If a crack is found in a MGB base plate, remove and replace the MGB with an airworthy MGB before further flight.
