Federal Register

[Docket No. FAA-2005-23221; Directorate Identifier 2005-CE-51-AD; Amendment 39-14459; AD 2006-02-51]

#### Airworthiness Directives; Raytheon Aircraft Company Model 390 Airplanes

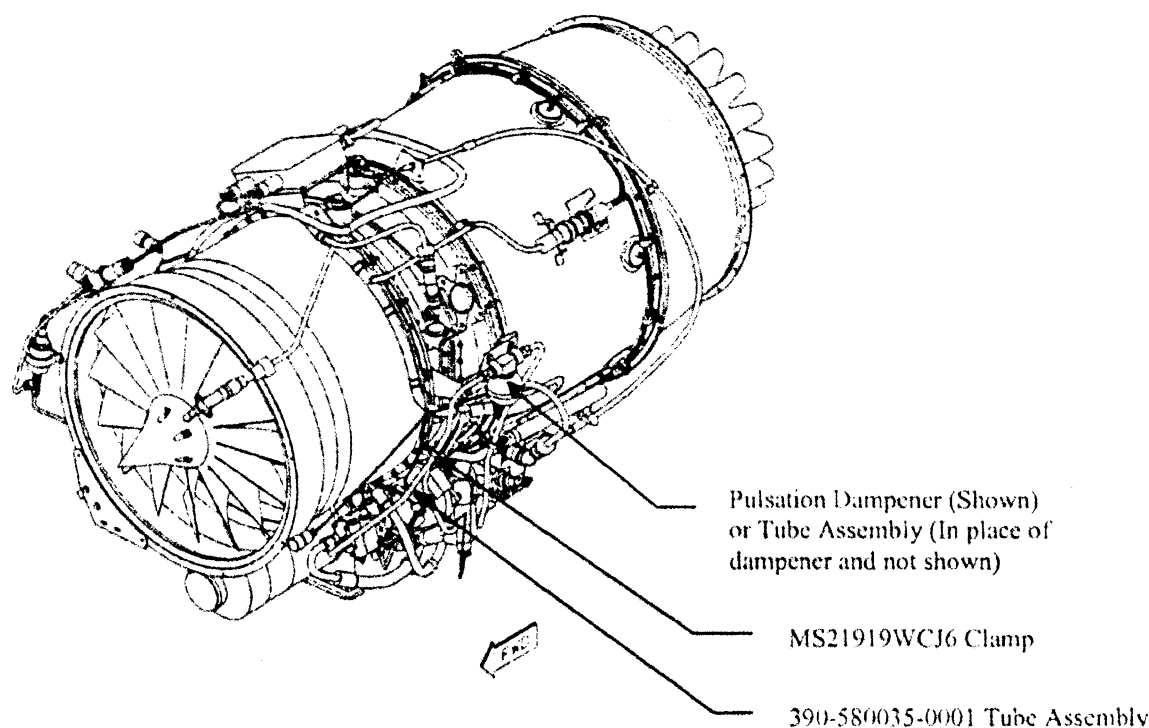
The FAA received reports of four failures of the part number (P/N) 390-580035-0001 hydraulic tube assembly located on the left engine assembly of Raytheon Model 390 airplanes. The failures resulted in in-flight loss of hydraulic fluid. The tube is installed between the hydraulic pump and the hydraulic pulsation damper and carries hydraulic pump output pressure.

(d) This AD is the result of failure of the hydraulic tube assembly, which caused in-flight loss of hydraulic fluid. We are issuing this AD to prevent failure of the hydraulic tube assembly and the clamp and consequent leaking of hydraulic fluid. This failure could result in loss of hydraulic system functions and risk of fire because of flammable fluid leakage in the engine nacelle and lead to loss of control of the airplane.

Figure 1. Hydraulic Tube Assembly with Clamp on Left Hand Engine.

Actions	Compliance	Procedures
<p>(1) Perform a one-time visual inspection of the hydraulic tube assembly and clamp using Raytheon Safety Communique No. 267, dated January 2006. Perform repetitive detailed inspections thereafter per Raytheon Mandatory Service Bulletin No. SB 29-3771, dated January, 2006.</p> <p>(i) The tube assembly part number is P/N 390-580035-0001 or P/N 390-580035-0005).</p> <p>(ii) The clamp part number is P/N MS21919WCJ6 or P/N MS21919WCJ7.</p> <p>(2) Replace the hydraulic tube assembly (P/N 390-580035-0001 or P/N 390-580035-0005) and the clamp (P/N MS21919WCJ6 or P/N MS21919WCJ7) (or FAA-approved equivalent part numbers) with new P/N 390-580035-0001 or P/N 390-580035-0005 and P/N MS21919WCJ7 (or FAA-approved equivalent part numbers) or used parts.</p> <p>(3) Report the results to FAA of each inspection or replacement required in paragraphs (e)(1) and (e)(2) of this AD. The Office of Management and Budget (OMB) approved the information collection requirements contained in this regulation under the provisions of the Paperwork Reduction Act of 1980 (44 U.S.C. 3501 and those following sections) and assigned OMB Control Number 2120-0056.</p>	<p>Visually inspect before further flight after February 2, 2006 (the effective date of this AD), except for those who received emergency AD 2006-02-51, issued January 19, 2006, unless already done. Perform the detailed inspection within 10 hours time-in-service (TIS) after February 2, 2006 (the effective date of this AD), except for those who received emergency AD 2006-02-51, issued January 19, 2006, unless already done. Inspect thereafter at intervals not to exceed 50 hours TIS. You may perform the detailed inspection before further flight instead of the visual inspection. Emergency AD 2006-02-51 contained the requirements of this amendment and became effective immediately upon receipt.</p> <p>Replace the clamp at each inspection. Replace the tube assembly prior to further flight after any inspection where evidence of chafing, excessive vibration, wear, deterioration, or hydraulic fluid leakage is found. Refer to SB 29-3771, dated January, 2006 for acceptance/rejection information for the tube assembly.</p> <p>Within 10 days after the inspection or replacement or within 10 days after February 2, 2006 (the effective date of this AD), except for those who received emergency AD 2006-02-51, issued January 19, 2006, whichever occurs later.</p>	<p>For the visual inspection, use Raytheon Safety Communique No. 267, dated January, 2006. For the detailed inspections, use the procedures in Raytheon Mandatory Service Bulletin No. SB 29-3771, dated January, 2006.</p> <p>Follow the procedures in Raytheon Mandatory Service Bulletin No. SB 29-3771, dated January, 2006.</p> <p>Include in your report the airplane serial number, the TIS of the airplane, and the TIS of the hydraulic tube assembly (P/N 390-580035-0001 or P/N 390-580035-0005) (or FAA-approved equivalent part number). E-mail/send your report to James P. Galstad, Propulsion Aerospace Engineer, ACE 116W, Wichita Aircraft Certification Office, 1801 Airport Road, Room 100, Wichita, Kansas 67209; e-mail: <a href="mailto:james.galstad@faa.gov">james.galstad@faa.gov</a>; telephone: 316-946-4135; facsimile: 316-946-4107.</p>
