[Docket No. FAA–2008–0101; Directorate Identifier 2007–SW–76–AD; Amendment 39–15357; AD 2007–26–51]

Airworthiness Directives; Eurocopter Deutschland GmbH Model EC135 Helicopters

2007–26–51 Eurocopter Deutschland

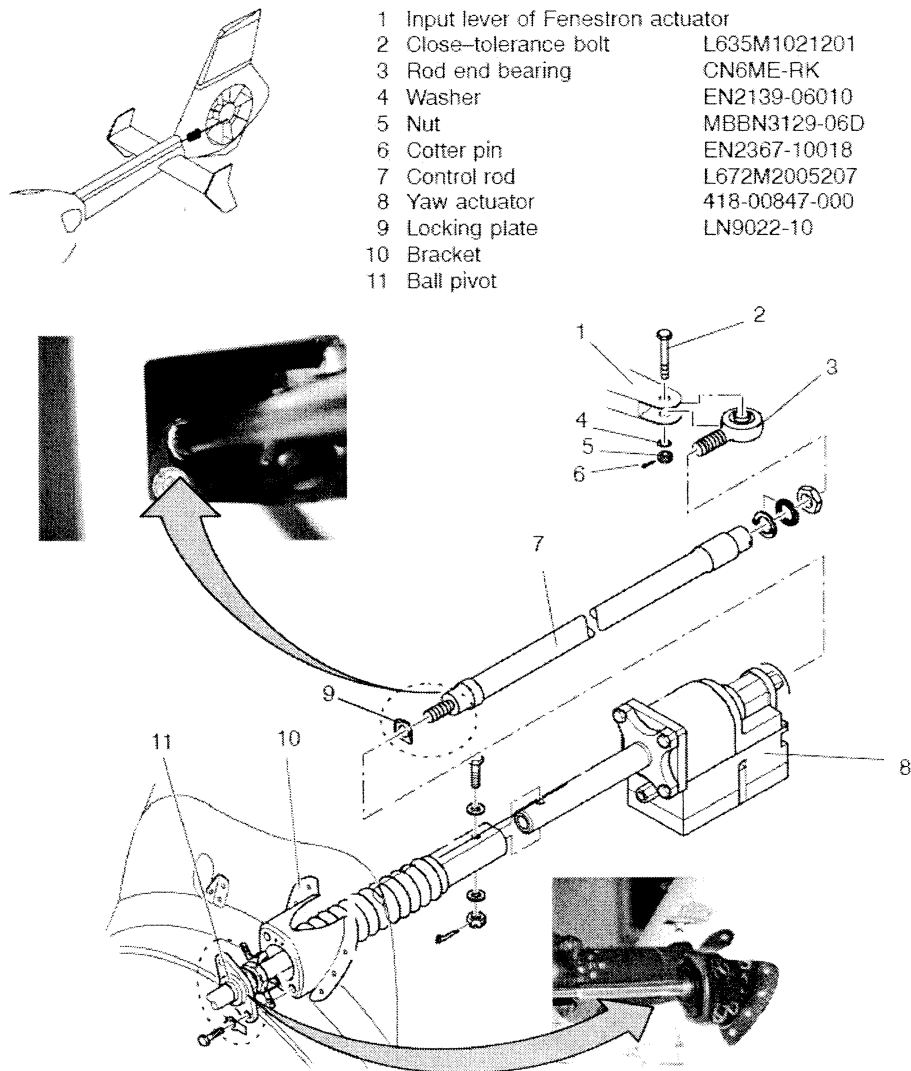
Ball Pivot and Control Rod
Figure 1

SUPPLEMENTARY INFORMATION: On December 14, 2007, the FAA issued Emergency AD 2007–26–51 for Eurocopter Model EC135 helicopters, which requires, within 5 hours TIS, inspecting the control rod and adjoining ball pivot and replacing any unairworthy parts before further flight. That action was prompted by a report of a fatal accident involving the failure of a control rod. This condition, if not corrected, could result in the failure of

The European Aviation Safety Agency (EASA), which is the Technical Agent for the Member States of the European Community, notified us that an unsafe condition may exist on Eurocopter EC135 and EC635 helicopters. EASA advises that an accident recently occurred with an EC135 helicopter in Japan. Preliminary investigation results indicate that the helicopter loss of control was due to the failure of the control rod.

(a) Within 5 hours time-in-service (TIS), inspect the control rod, shown in item 7, Figure 1, of this AD, with the parts identified in parenthesis as follows:

(1) Pull the control rod (7) until it reaches its stop position. Inspect attachment hardware of control rod (7) for a tight fit. Manually inspect for possible relative motion between control rod (7) and yaw actuator (8).

(2) Inspect the locking plate (9) for a tight fit.

(3) Visually inspect the attachment hardware between control rod (7) and yaw actuator (8) for play or thread exposure. If play or thread exposure is found, before further flight, replace the control rod with an airworthy control rod.

(b) Inspect the ball pivot as shown in item 11, Figure 1, of this AD by removing the tail rotor drive shaft fairing and inspecting for a loose bearing or play. If a loose bearing or play is found, before further flight, replace the ball pivot with an airworthy ball pivot.
