[Docket No. FAA–2008–1207; Directorate Identifier 2007–NE–47–AD; Amendment 39–15880; AD 2009–08–07]

## Airworthiness Directives; Honeywell International Inc. ALF502L–2 and ALF502L–2C Turbofan Engines

**SUMMARY:** The FAA is adopting a new airworthiness directive (AD) for Honeywell International Inc. ALF502L–2 and ALF502L–2C turbofan engines with certain high-pressure compressor (HPC) first stage discs installed. This AD requires performing a dimensional inspection to determine if excessive disc balance material was removed and a magnetic particle inspection if the disc

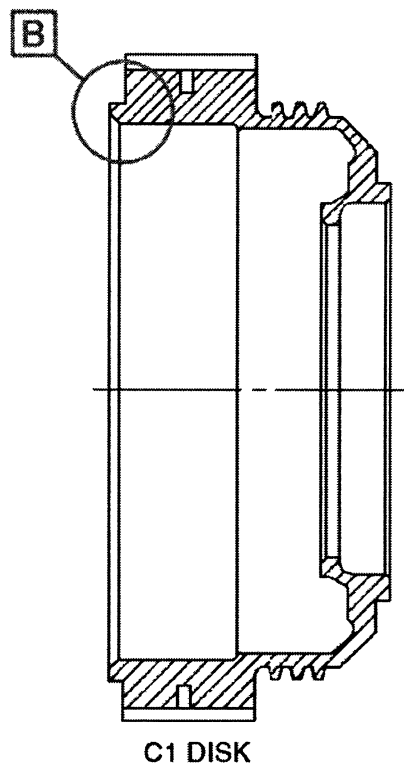
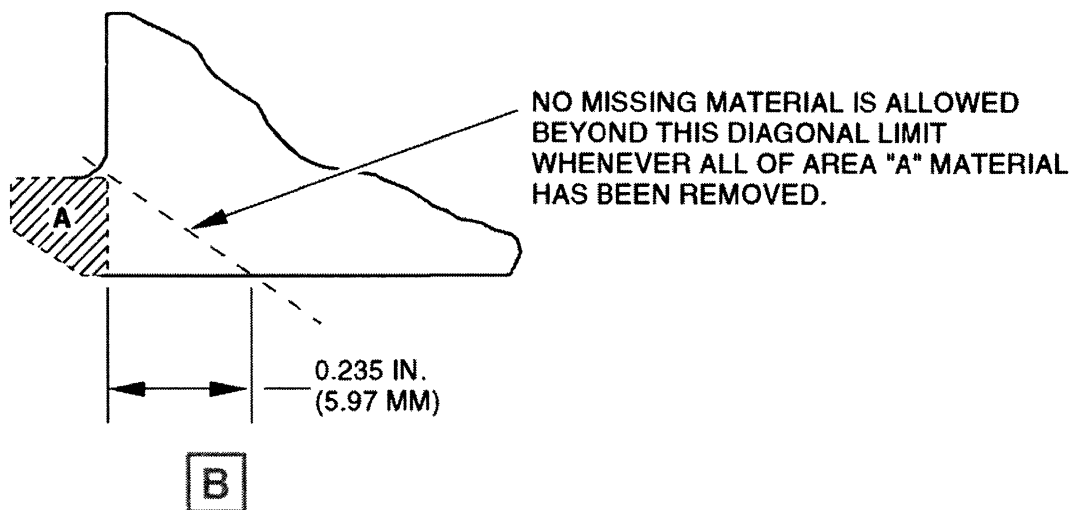
Limits for Removed Balance Material, Disc Forward Flange  
Figure 1 (Sheet 1 of 2)

- (f) For discs with 5,000 or more cycles-since-new on the effective date of this AD, perform a dimensional inspection of the HPC first stage disc to determine if excessive disc

balance material was removed. See the following Figure 1 for limits.

(g) Replace the disc if excessive disc balance material was removed. See limits in Figure 1 of this AD.

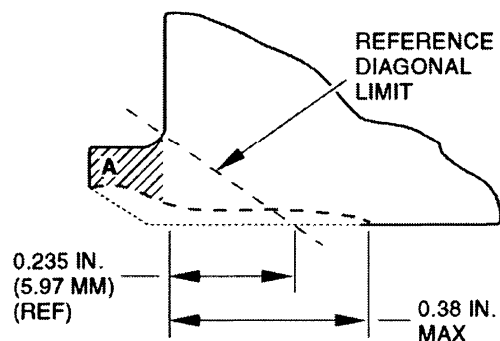
Any remaining Area 'A' lip material is sufficient to permit axial material removal up to 0.38 inch (9.7 mm) limit. Surface shall have a smooth contour and 0.020 inch (0.51 mm) minimum blend radius.

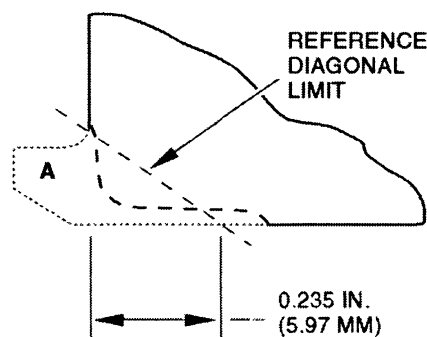
No Area 'A' material remaining and 0.235 inch (5.97 mm) diagonal limit is exceeded.
