[Docket No. FAA–2010–0342; Directorate Identifier 2002–NE–08–AD]

Airworthiness Directives; Bombardier-Rotax GmbH Type 912 F, 912 S, and 914 F Series Reciprocating Engines

ACTION: Notice of proposed rulemaking (NPRM).

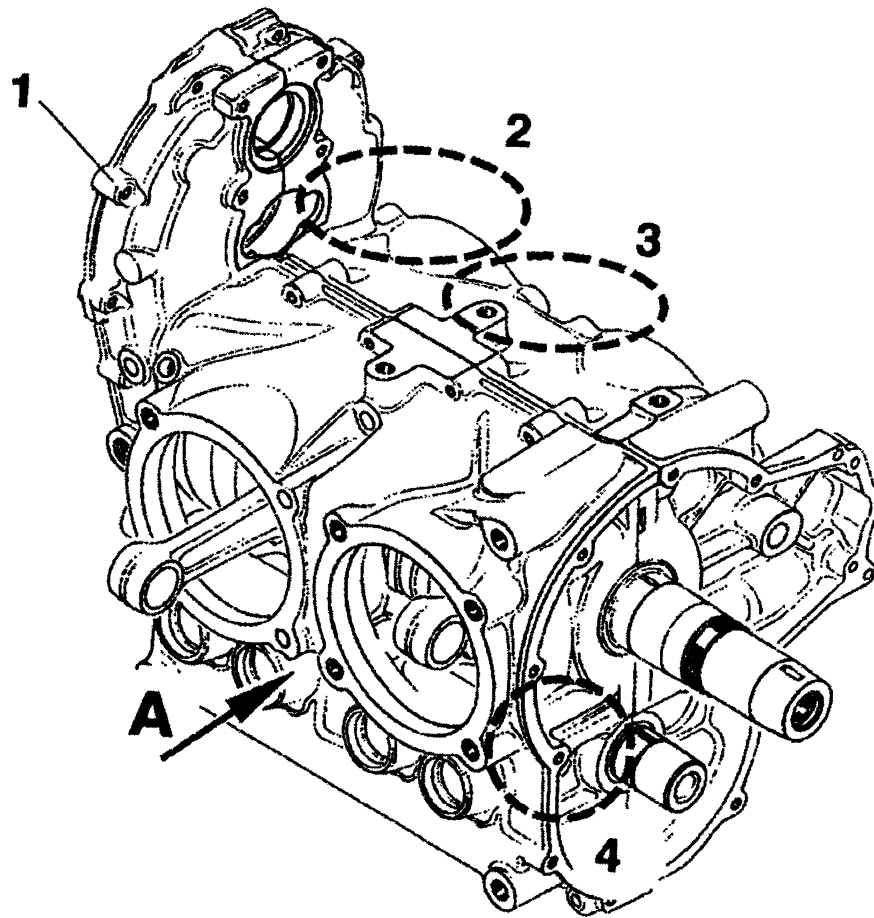
Figure 1. Engine Crankcase Inspection Areas

(1) Inspect the engine crankcase (item 1, Figure 1 of this AD) for cracks, especially in the area of cylinder 1 upper side (item 2), between cylinder 1 and 3 upper side (item 3), cylinder 4 lower-right side (item 4) and detailed inspection in the area identified in Figure 2 (item 5) of this AD. Information concerning this inspection can be found in Bombardier-Rotax Mandatory Service Bulletins No. SB–912–029, Revision 3, dated July 11, 2006 and No. SB–914–018, Revision 3, dated July 11, 2006.

(2) Cracks in crankcases of engines with a ROTAX cooling air baffle may not be easily visible, and oil leaks may be an indication of cracks. Visually inspect for oil leaks in areas of (item 2, Figure 1 of this AD) and (item 3).

(4) If the engine crankcase is cracked, replace the engine before further flight.

(h) Visually inspect the engine crankcase (item 1, Figure 1 of this AD) for cracks at each 100-hour, annual, or progressive inspection, or within 110 hours TIS since last inspection, whichever occurs first, in accordance with paragraphs (g)(1) through (g)(4) of this AD.

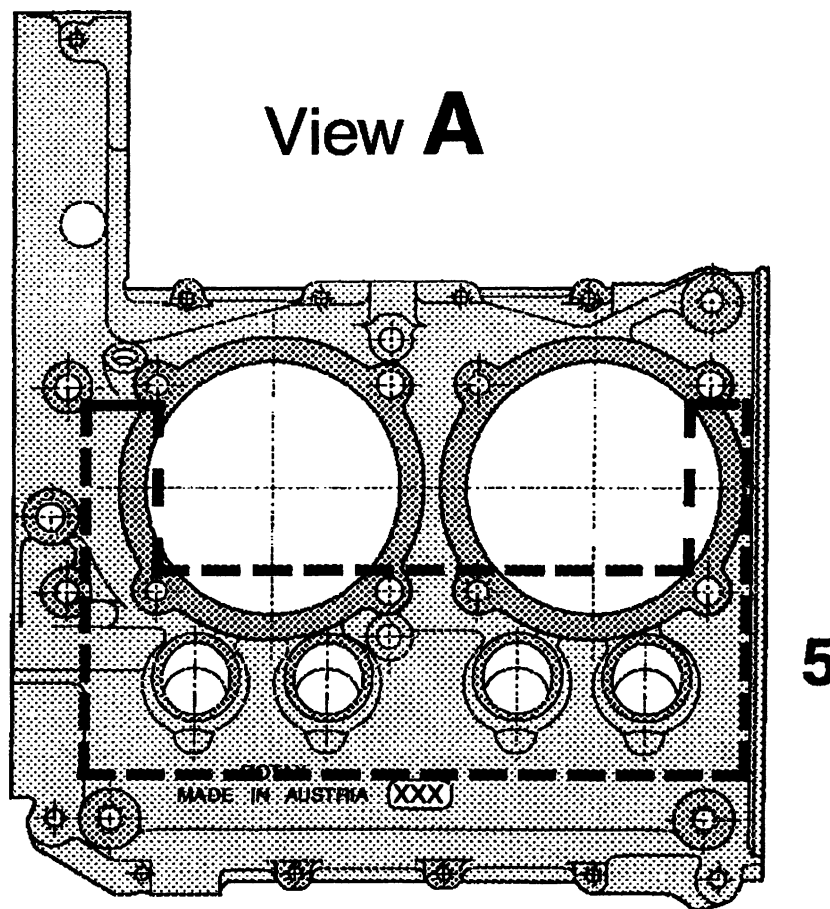
Figure 2. Engine Crankcase Inspection Areas – View A

(f) Determine if your crankcase is affected by looking at the S/N in the area indicated by XXX, following “Made in Austria,” as shown on Figure 2 of this AD. The marking is on both crankcase halves.
