DEPARTMENT OF TRANSPORTATION

Federal Aviation Administration

[Docket No. FAA-2010-1013; Directorate Identifier 2010-CE-048-AD; Amendment 39-16478; AD 2010-21-18]

Airworthiness Directives; Cessna Aircraft Company (Cessna) Models 336, 337, 337A (USAF 02B), 337B, M337B (USAF 02A), T337B, 337C, T337C, 337D, T337D, 337E, T337E, 337F, T337F, 337G, T337G, 337H, P337H, T337H, T337H-SP, F337E, FT337E, F337F, FT337F, F337G, FT337GP, F337H, and FT337HP Airplanes

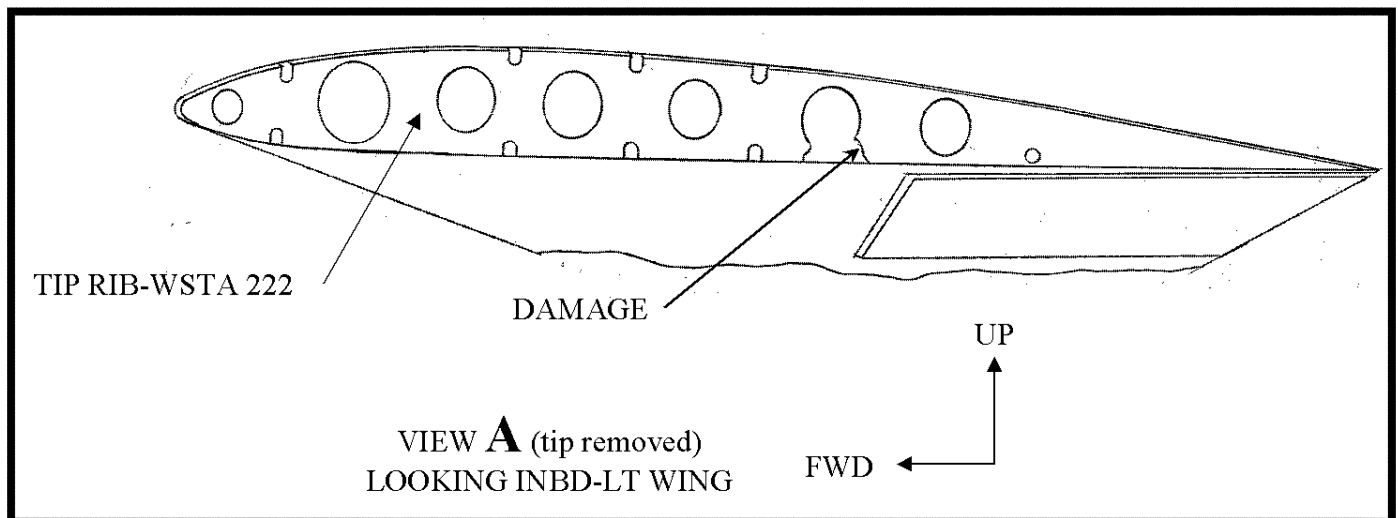
Figure 2

(11) Inspect rib at WSTA 222 for damage. Trimming of the rib may have been done to allow installation of fuel lines (See View A, Figure 2). Repair in accordance with AC 43.13-1B, Chapter 4, paragraph 4-58(g) and Figure 4-14, or by using another FAA-approved method that restores equivalent strength of the wing rib.

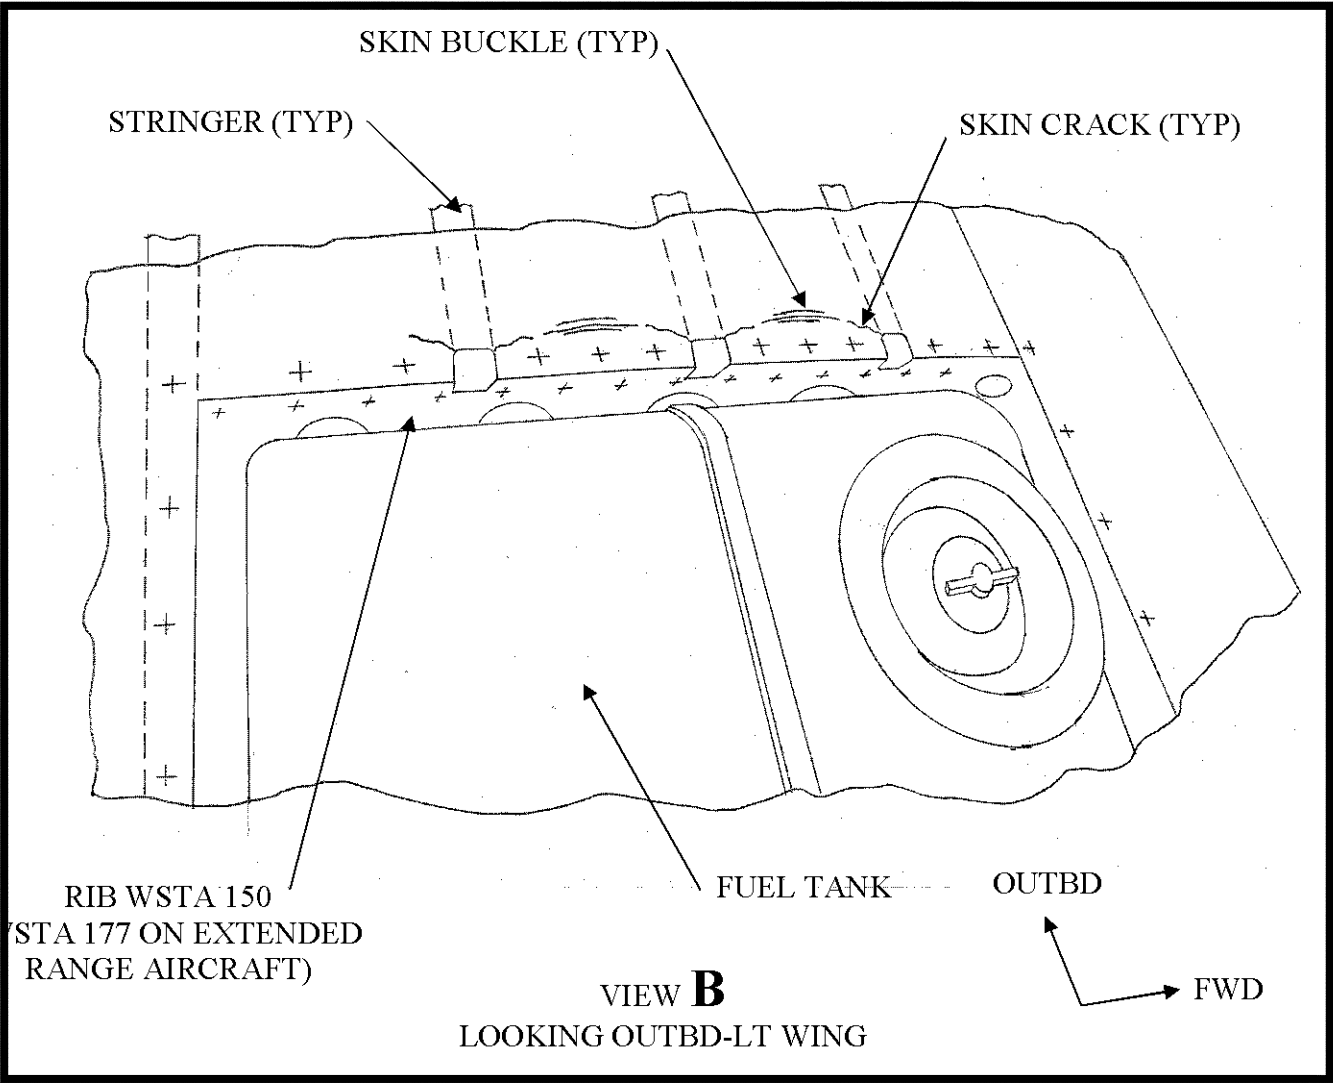
Figure 3

(1) Wrinkles in upper wing skins, from the outboard edge on the fuel tank access covers (WSTA 150 or 177) to the WSTA 222 (See View B, Figure 3).

(3) Cracking of the upper wing skins. Pay particular attention to any wrinkles, the radius between stiffeners at WSTA 150 (under fuel tank covers), and unreinforced access holes (See View B, Figure 3).

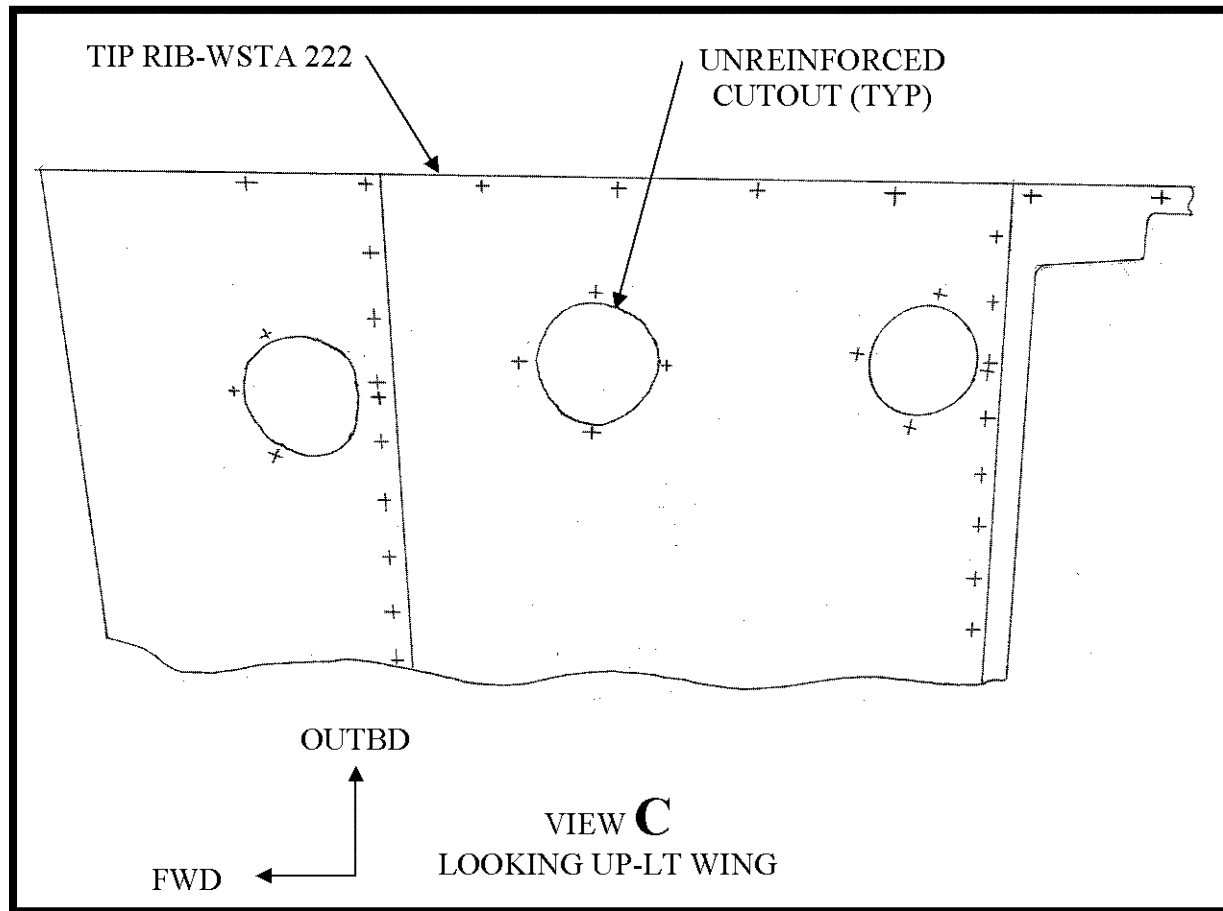
Figure 4

(2) Inspect wing skins for unreinforced cutouts. (See View C, Figure 4).

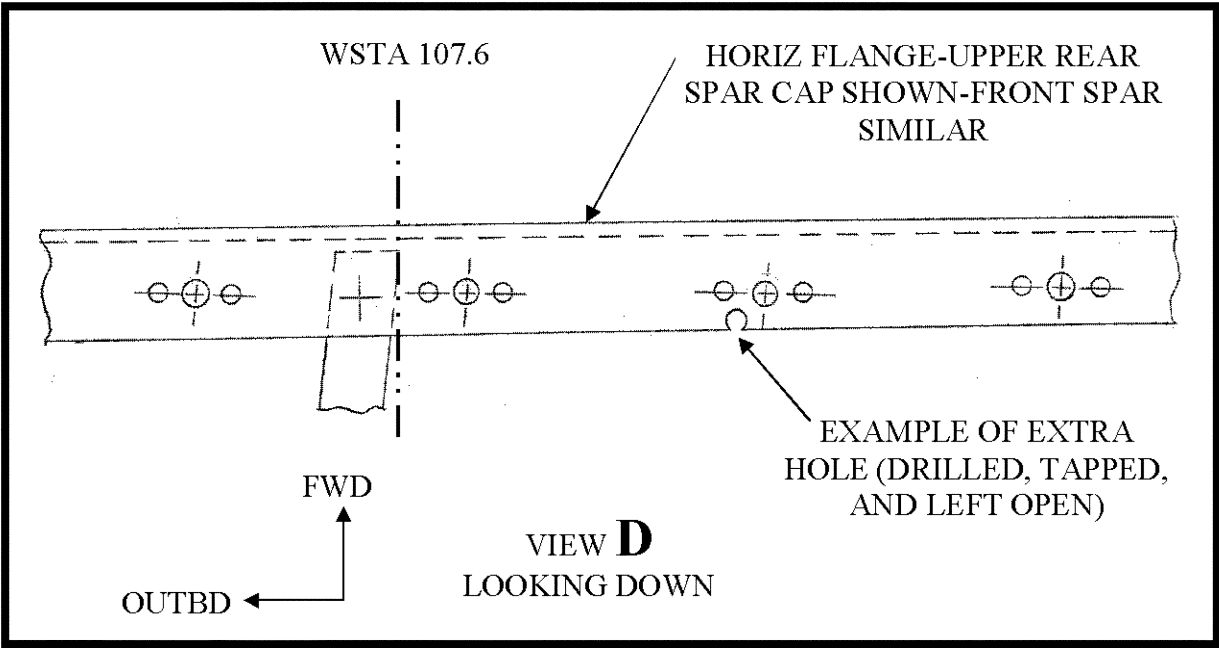
Figure 5

(3) Inspect the upper spar cap horizontal flanges for open holes (See View D, Figure 5).

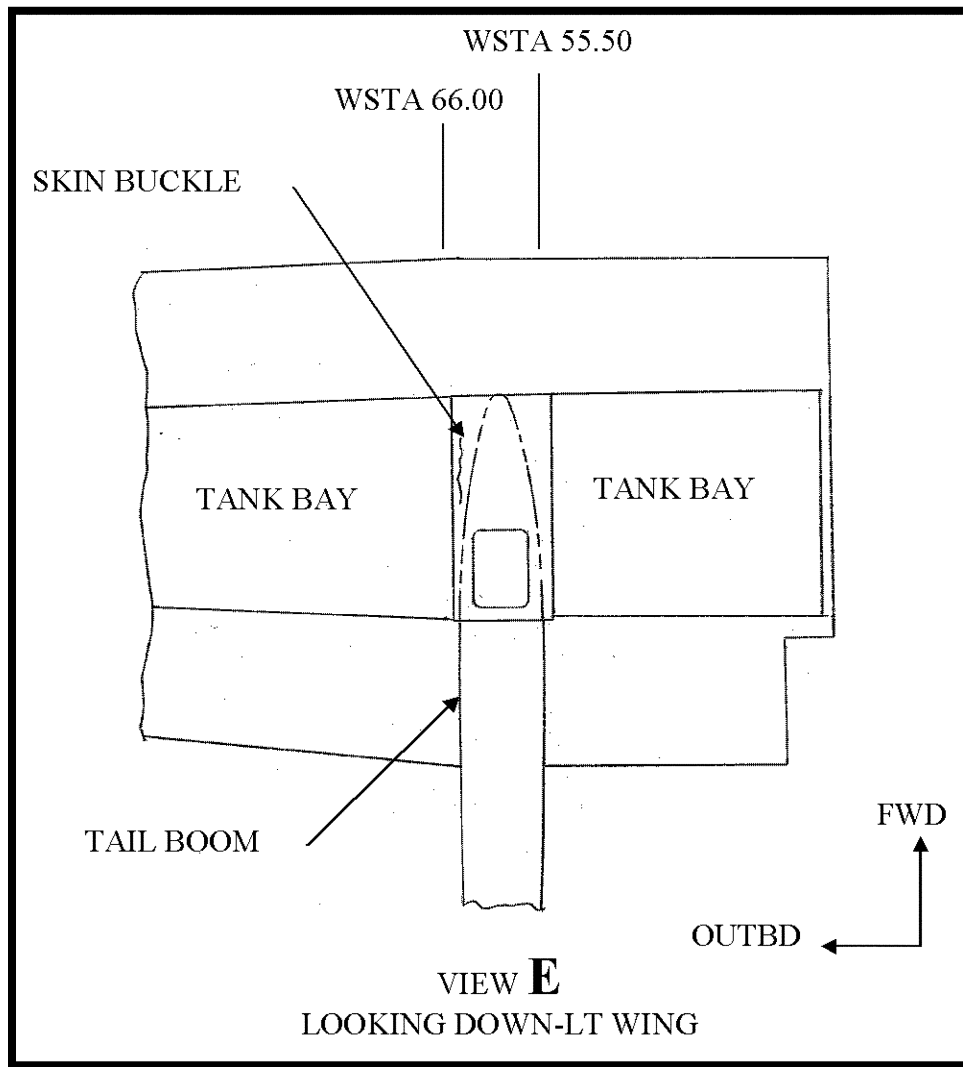
Figure 6

(2) Wrinkles in the upper wing skins from WSTA 55 to 66, adjacent to the booms (See View E, Figure 6).

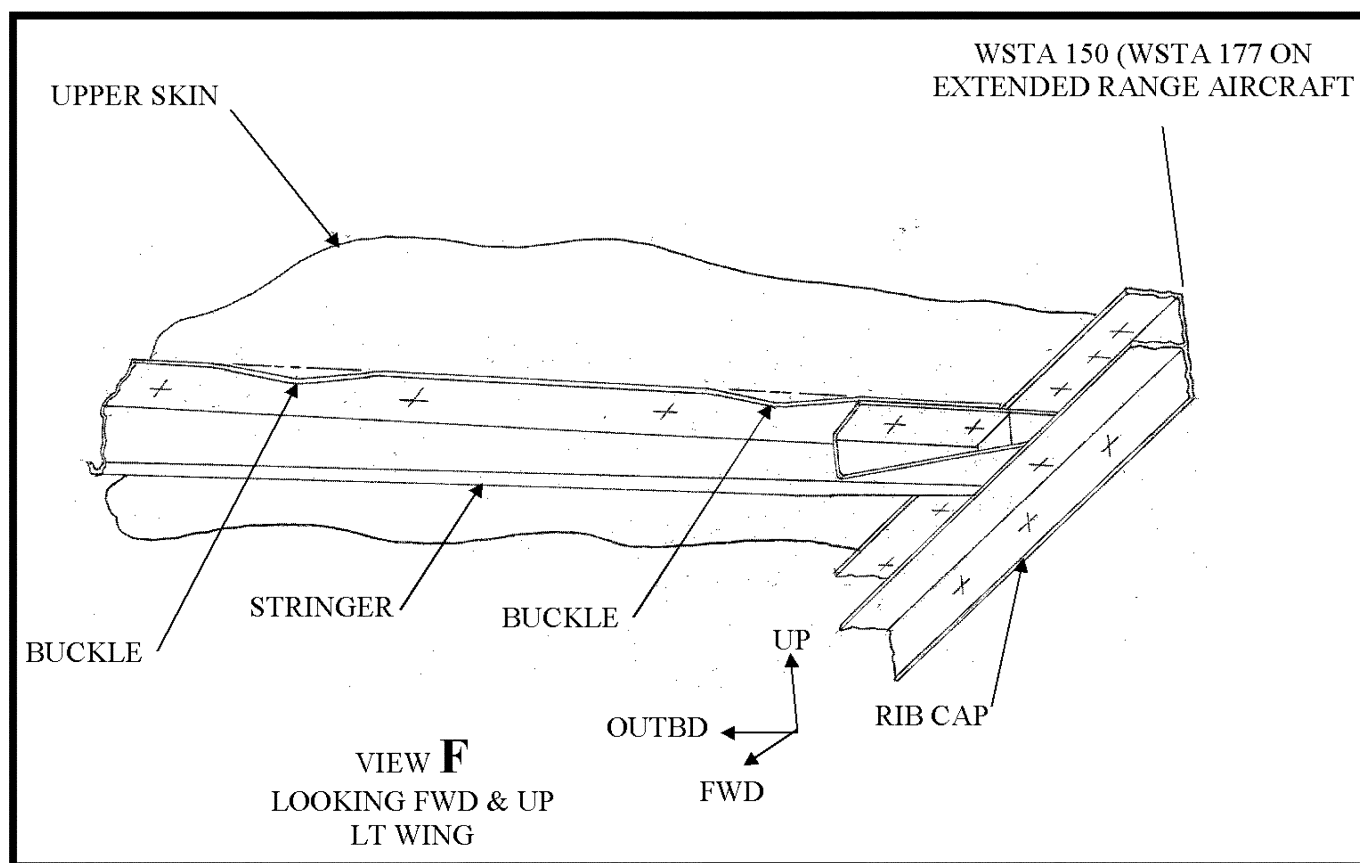
Figure 7

(10) Inter-rivet buckling of the stringers attached to the upper surface skin, outboard of the fuel tank access covers (See View F, Figure 7).
