[Docket No. FAA–2009–1253; Directorate Identifier 2009–NM–080–AD; Amendment 39–16629; AD 2011–06–05]

Airworthiness Directives; The Boeing Company Model 737–600, –700, –700C, –800, –900, and –900ER Series Airplanes

ACTION: Final rule.

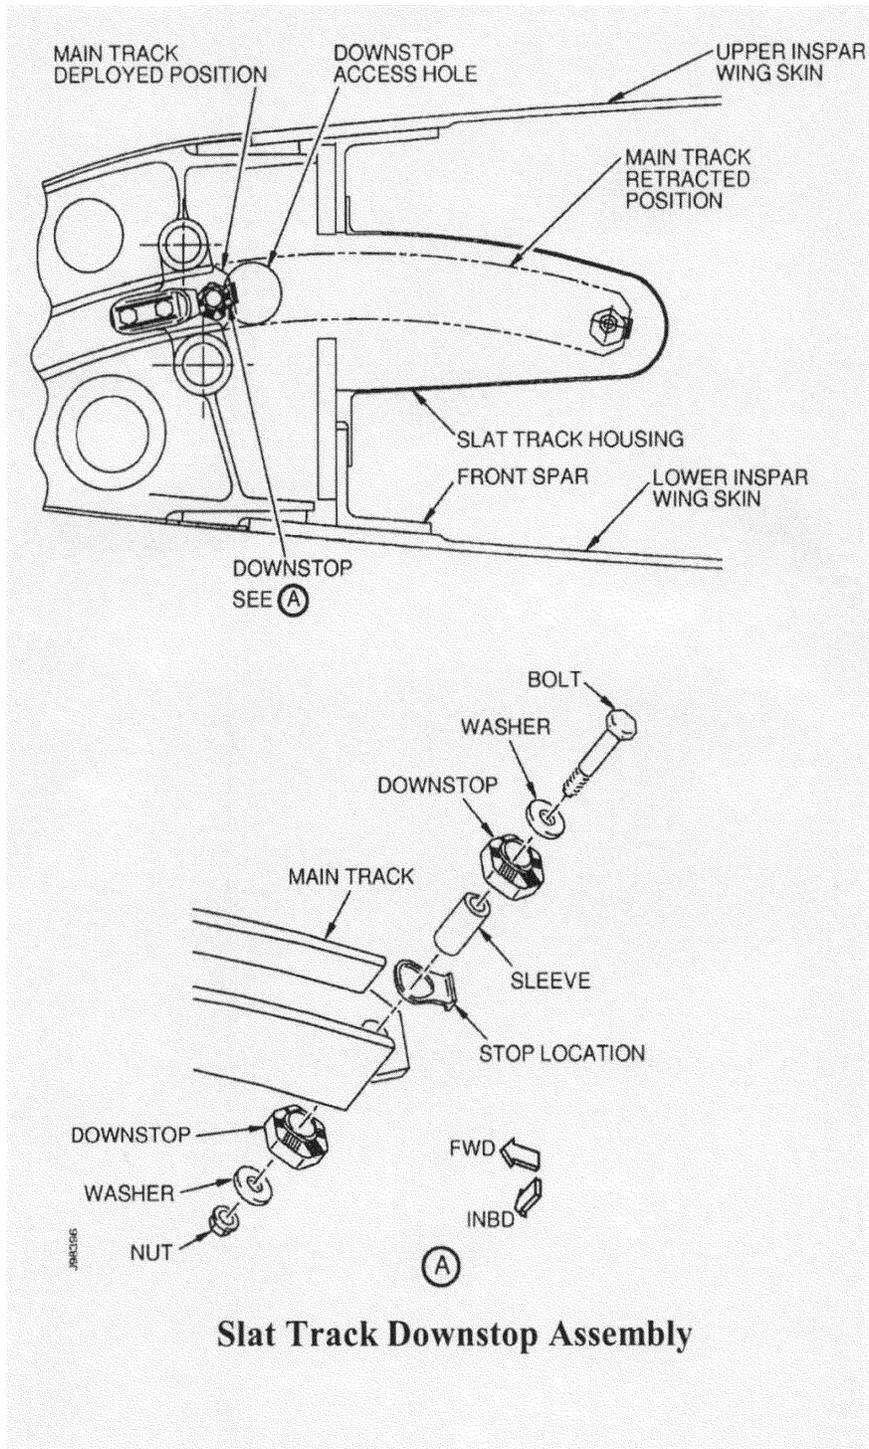
- (e) This AD results from reports of parts coming off the main slat track downstop assemblies. The Federal Aviation Administration is issuing this AD to prevent loose or missing parts from the main slat track downstop assemblies from falling into the slat can and causing a puncture, which could result in a fuel leak and consequent fire.

- (g) Within 10 days after September 26, 2007 (the effective date of AD 2007-18-52): Do a detailed inspection or a borescope inspection of each main slat track downstop assembly to verify proper installation of the slat track hardware (*i.e.*, the bolt, washers, downstops, stop location, and nut shown in Figure 1 of Boeing Service Letter 737-SL-57-084-B, dated July 10, 2007, and in this AD). Proper installation of the sleeve need not be confirmed, and the stop location part may be installed on either the inboard or the outboard side of the slat track. If any part is missing or is installed improperly, before further flight, install a new or serviceable part using a method approved in accordance with the procedures specified in paragraph (j) of this AD; and do a detailed inspection of the inside of the slat can for foreign object debris (FOD) and damage. Before further flight, remove any FOD found and repair any damage found using a method approved in accordance with the procedures specified in paragraph (j) of this AD. Verify proper installation; install a new or serviceable part; and inspect for damage and FOD, and remove FOD and repair damage; in accordance with a method by approved by the Manager, Seattle Aircraft Certification Office, FAA; or in accordance with Boeing Multi Operator Message Number 1-523812011-1, issued August 25, 2007, or 1-527463441-1, issued August 28, 2007. Repeat the actions required by paragraph (g) of this AD thereafter at intervals not to exceed 3,000 flight cycles.

Slat Track Downstop Assembly

- (h) Within 24 days after receipt of emergency AD 2007-18-51: Apply a torque between 50 to 80 inch-pounds to the nut. The bolt head must be held with the torque applied to the nut.

(i) Within 36 months after the effective date of this AD: Replace the hardware of the down stop assembly with new hardware, do a detailed inspection or a borescope inspection of the slat cans on each wing and the lower rail of the slat main tracks for
