Federal Register

[Docket No. FAA-2016-9418; Directorate Identifier 2016-NE-23-AD]

Airworthiness Directives; Honeywell International Inc. Turboprop and Turboshaft Engines

ACTION: Notice of proposed rulemaking (NPRM).

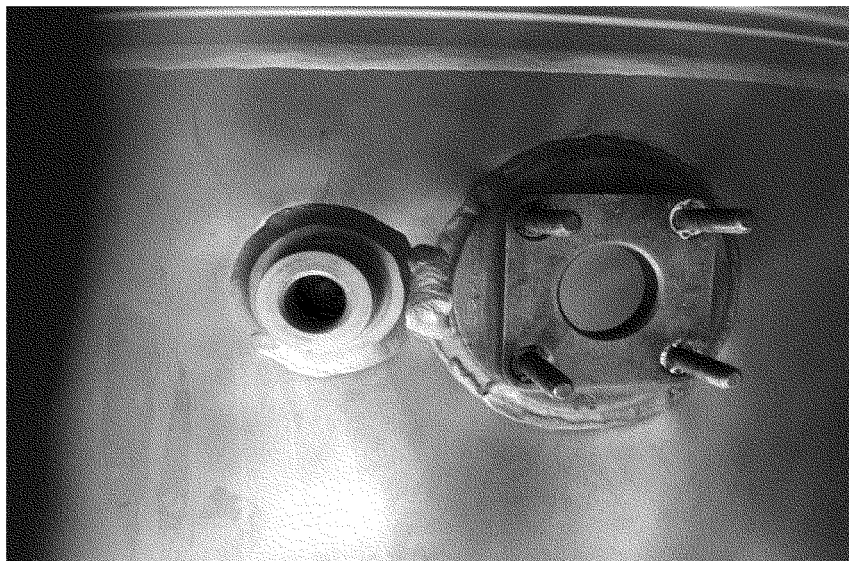
**Figure 1 to Paragraph (g) of this AD. Combustion Chamber Case Assembly
Without the One-Piece Bleed Pad with P3 Boss**

(2) For TPE331-3U, -3UW, -5, -5A, -5AB, -5B, -6, -6A engines with combustion chamber case assemblies, part numbers (P/Ns) 869728-1, 869728-3, or 893973-5, installed, and without the one-piece bleed pad with P3 boss, and for TPE331-1, -2, and -2UA engines modified with increased P3 pressures, including, but not limited to, engines modified by supplemental type certificate (STC) SE383CH, remove the combustion chamber case assembly from service at the next removal of the combustion chamber case from the engine.

(2) Figures 1 and 2 to paragraph (g) of this AD illustrate the appearance of combustion chamber case assembly, P/N 893973-5, without and with, respectively, the one-piece bleed pad with the P3 boss.

After the effective date of this AD, do not install a combustion chamber case assembly, P/N 869728-1, 869728-3, or 893973-5, in an engine, unless the combustion chamber case assembly has a one-piece bleed pad with P3 boss.
