DEPARTMENT OF TRANSPORTATION

Federal Railroad Administration

[FRA Emergency Order No. 24; Docket No. FRA-2005-22796, Notice No. 1]

Emergency Order Requiring Special Handling, Instruction and Testing of Railroad Operating Rules Pertaining to Hand-Operated Main Track Switches

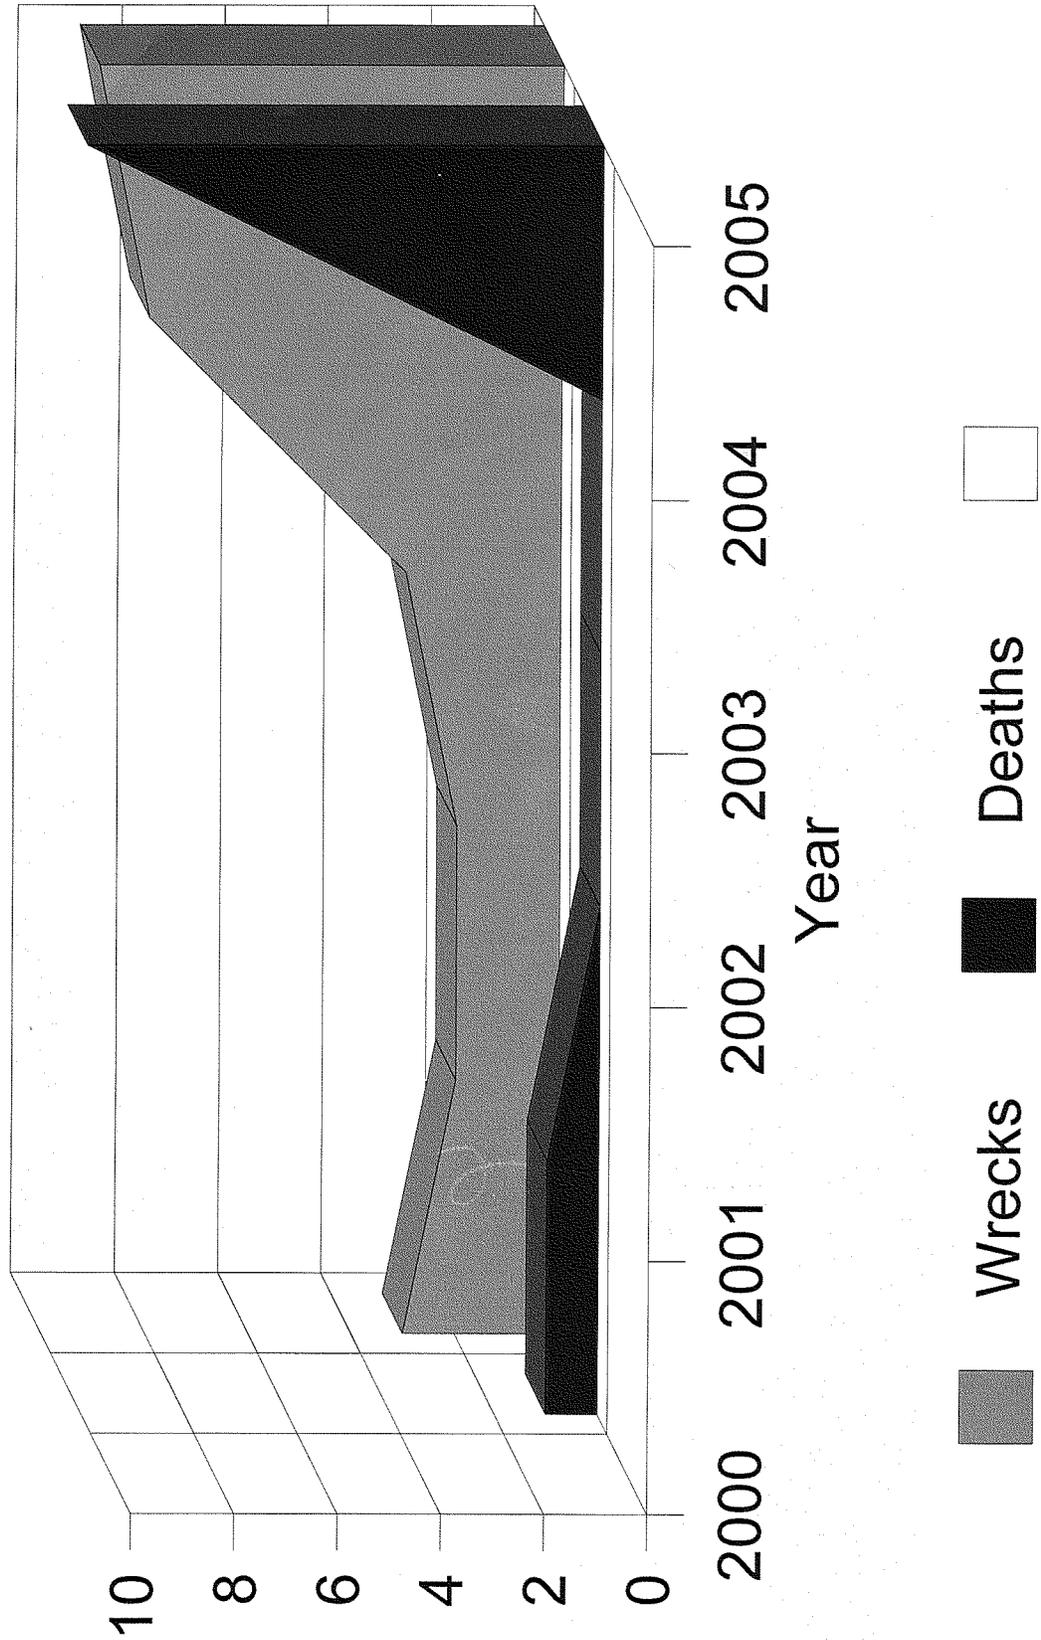
# Wrecks & Deaths

In comparison, in 2004 there was a sharp increase in the frequency and severity of collisions resulting from improperly lined main track switches as shown on the attached charts. In 2004, there were a total of eight accidents resulting in eight injuries to railroad employees. The increase in the number of accidents and injuries did not go unnoticed by the industry as some railroads amended their operating rules to address this issue.

*Finding and Order:* Collisions, deaths and injuries resulting from improperly lined main track switches began in 2004 to rise very sharply as shown on the attached charts. FRA's issuance of a Safety Advisory in early January 2005, recommending practices designed to prevent such events, led to a nearly six month respite. The sharply rising and accelerating trend of collisions, deaths and injuries resulting from improperly lined main track switches, which the Safety Advisory abated only temporarily, constitutes an emergency situation involving a hazard of death or personal injury which FRA must act to stop.
