**[Docket No. FAA-2007-28688; Directorate Identifier 2005-SW-21-AD; Amendment 39-15312; AD 2007-26-10]**

#### Airworthiness Directives; Bell Helicopter Textron Canada Model 430 Helicopters

##### 2007-26-10 Bell Helicopter Textron

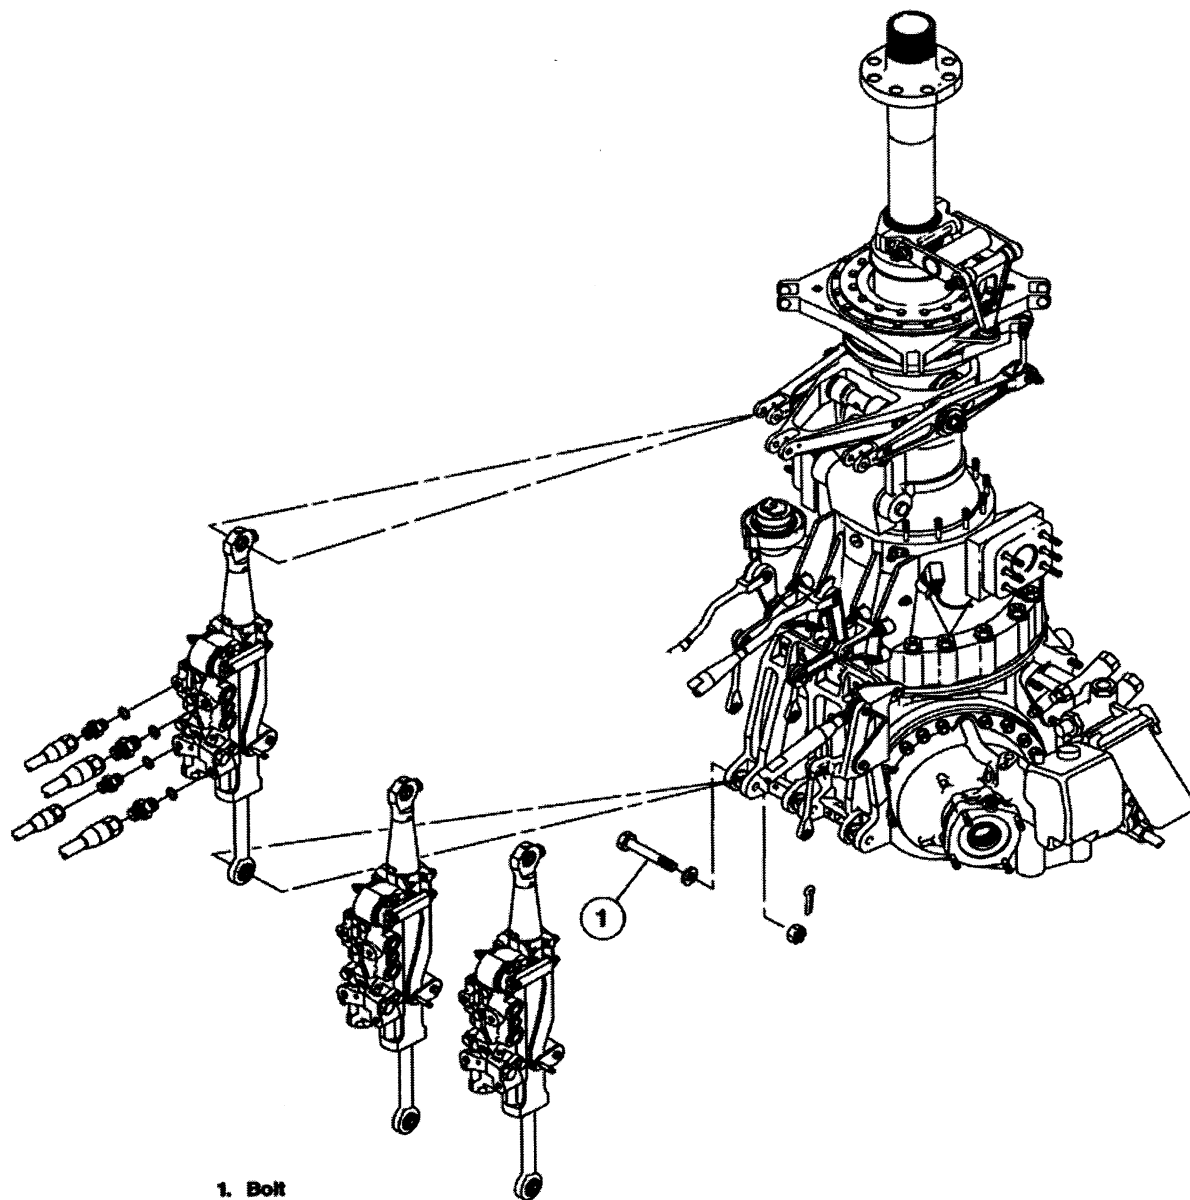
**Note 1:** Only the right servo lower attach bolt (1) is shown. The collective and left cyclic servo lower attach bolts are also to be replaced. (This AD does not apply to the same part-numbered bolts at the upper end of each servo.)

- (a) Within 150 hours time-in-service (TIS), replace all three affected bolts, as depicted for one of these bolts in Figure 1 of this AD, with airworthy, zero-time bolts, P/N 50-047C8-31.
