[Docket No. 99-SW-02-AD]

Airworthiness Directives; Bell Helicopter Textron-manufactured Model HH-1K, TH-1F, TH-1L, UH-1A, UH-1B, UH-1E, UH-1F, UH-1H, UH-1L, and UH-1P Helicopters; and Southwest Florida Aviation SW204, SW204HP, SW205, and SW205A-1 Helicopters

ACTION: Notice of proposed rulemaking (NPRM).

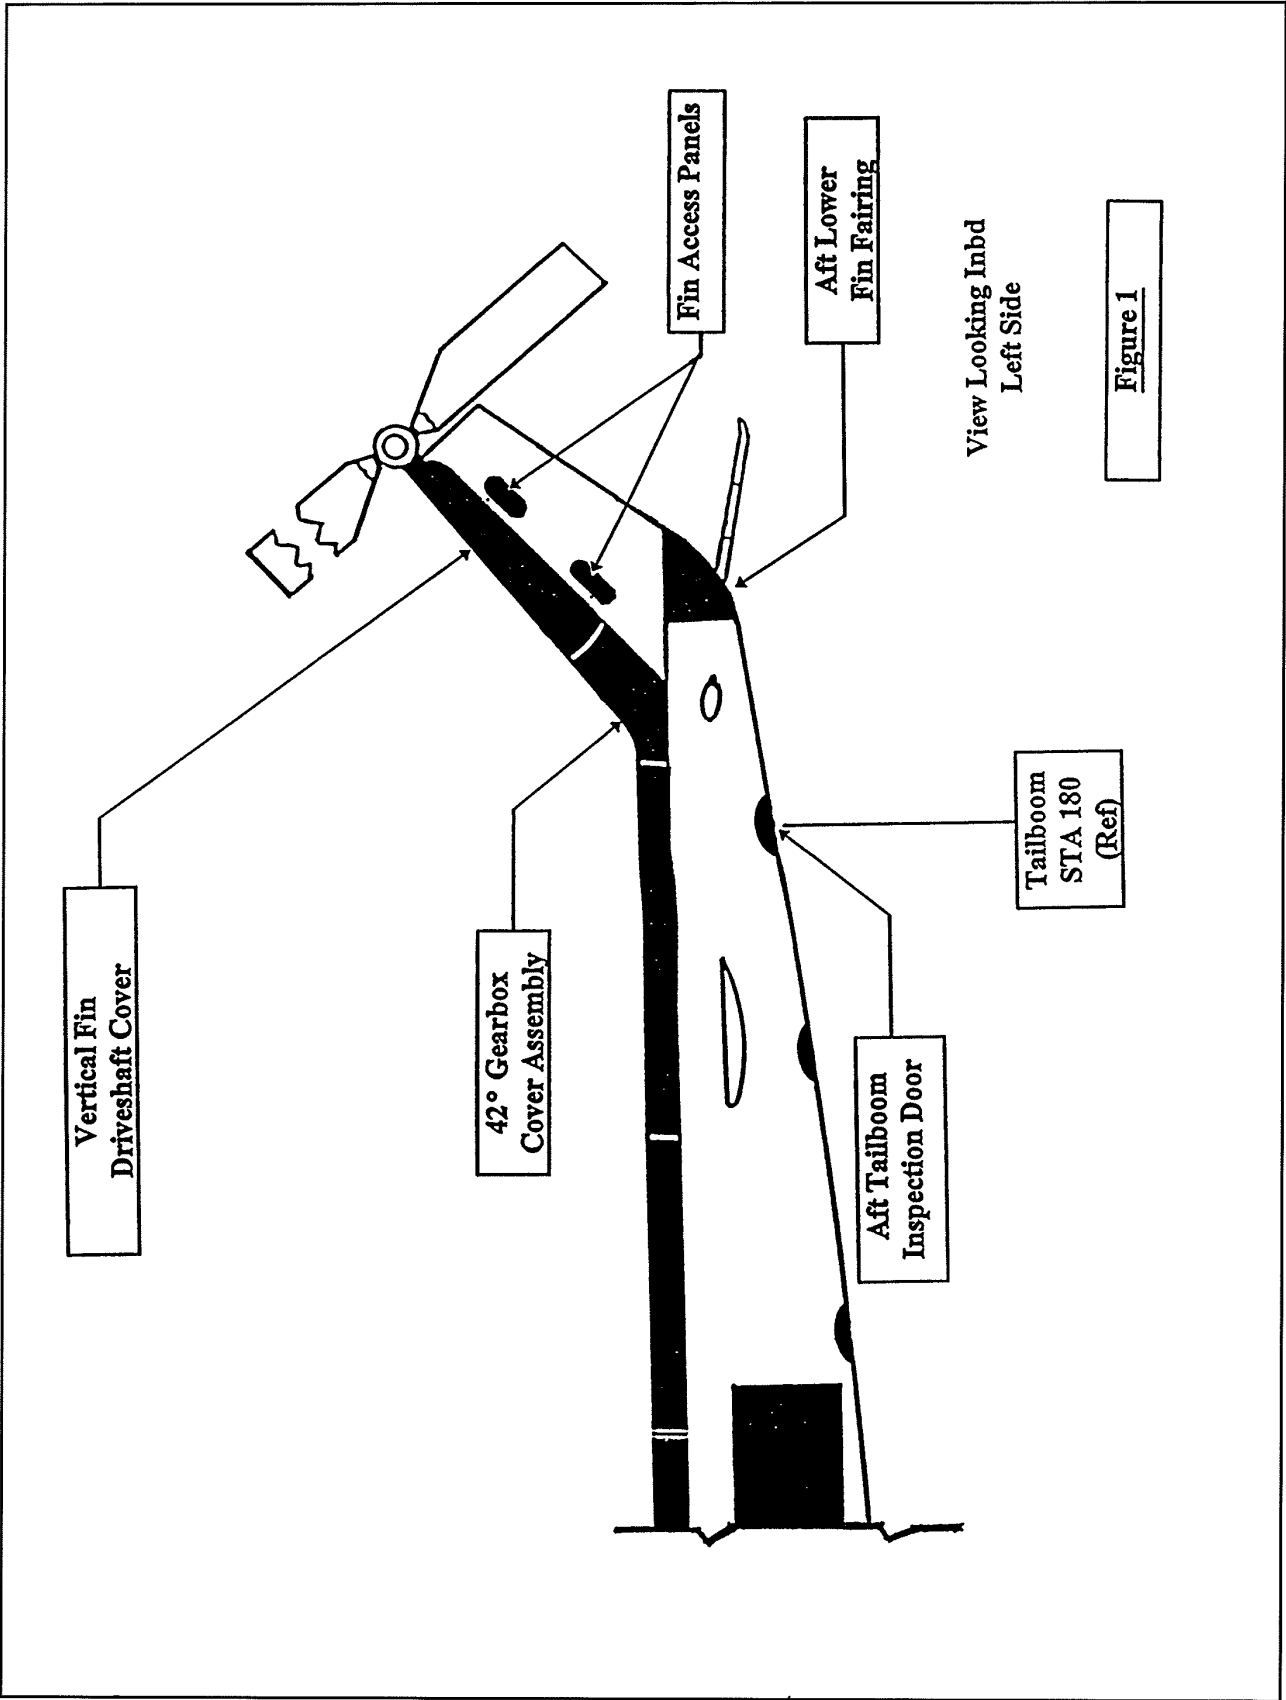
SUMMARY: This document proposes the superseding of an existing airworthiness directive (AD), applicable to Bell Helicopter Textron (Bell)-manufactured Model HH-1K, TH-1F, TH-1L, UH-1A, UH-1B, UH-1E, UH-1F, UH-1H, UH-1L, and UH-1P helicopters; and Southwest Florida Aviation SW204, SW204HP, SW205, and SW205A-1 helicopters that currently requires modification and inspections of the tailboom vertical fin spar (vertical fin spar). This action would require the same modification and inspections plus two additional inspections, and replacement of the vertical fin spar. This proposal is prompted by 2 accidents involving fatigue cracks in the vertical fin spar that have occurred since the issuance of AD 97-20-09. The actions specified by the proposed AD are intended to prevent in-flight failure of the vertical fin spar and subsequent loss of control of the helicopter.

- (a) Within 8 hours time-in-service (TIS), modify the vertical fin spar as follows:
 - (1) Remove the 42° gearbox cover and open the drive shaft cover on the fin spar assembly (see Figure 1).
 - (2) Remove the first four rivets from the fin spar located at the bottom of the fin spar left-hand side at the tailboom and fin spar junction, and the first four rivets aft of the junction along the lower edge of the fin spar side-skin as shown (see Figure 2).
 - (3) Trim the fin spar left-hand skin using extreme care to not damage the fin spar assembly (see Figure 3).
